## **Detailed Post-Wildfire Natural Hazard Risk Analysis Teare Creek Fire (G30210)**

**BC Wildfire Service**

**Westrek Geotechnical Services Ltd.**

March 12, 2024  
File No. 023-215

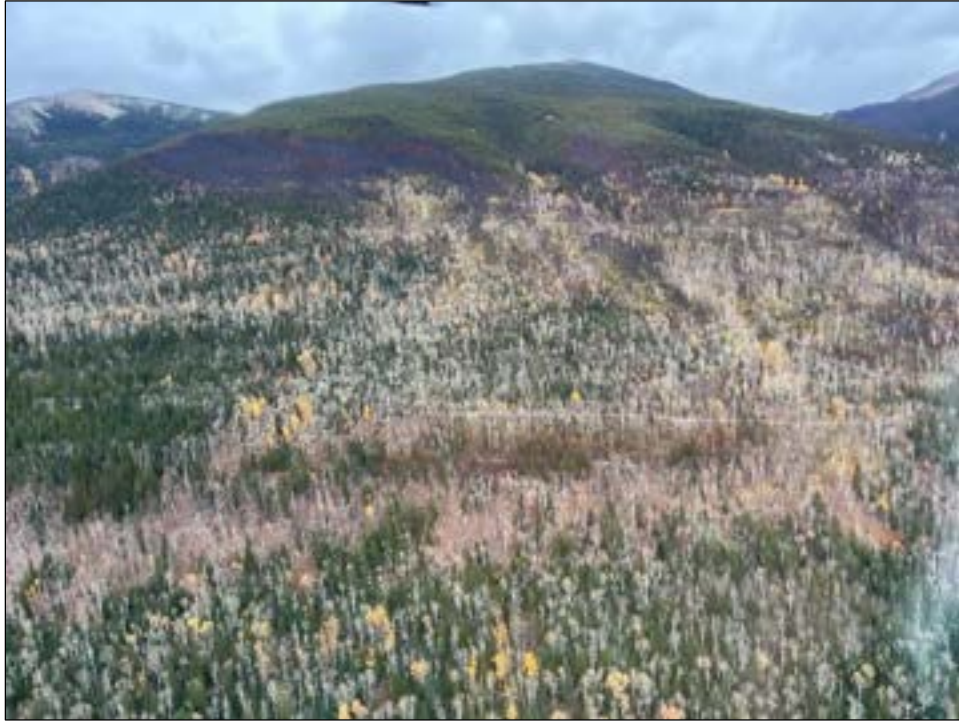
**Photo 1:** View of Face Unit 1. The upper slopes appear to have burned more severely; this may reflect the dominance of coniferous trees in the stand, which tend to burn more intensely.

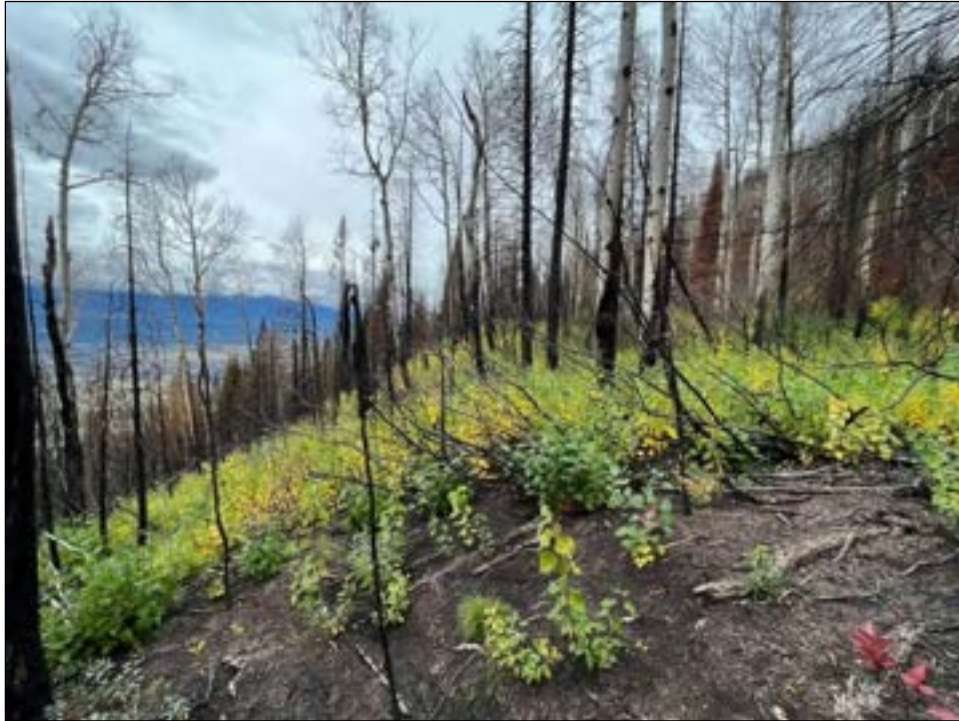
**Photo 2:** View looking northwest across the mid-slopes of Face Unit 1. Mixed deciduous and coniferous trees have lost their canopy, but many are only partially burned, suggesting the burn severity mapping may be conservative.

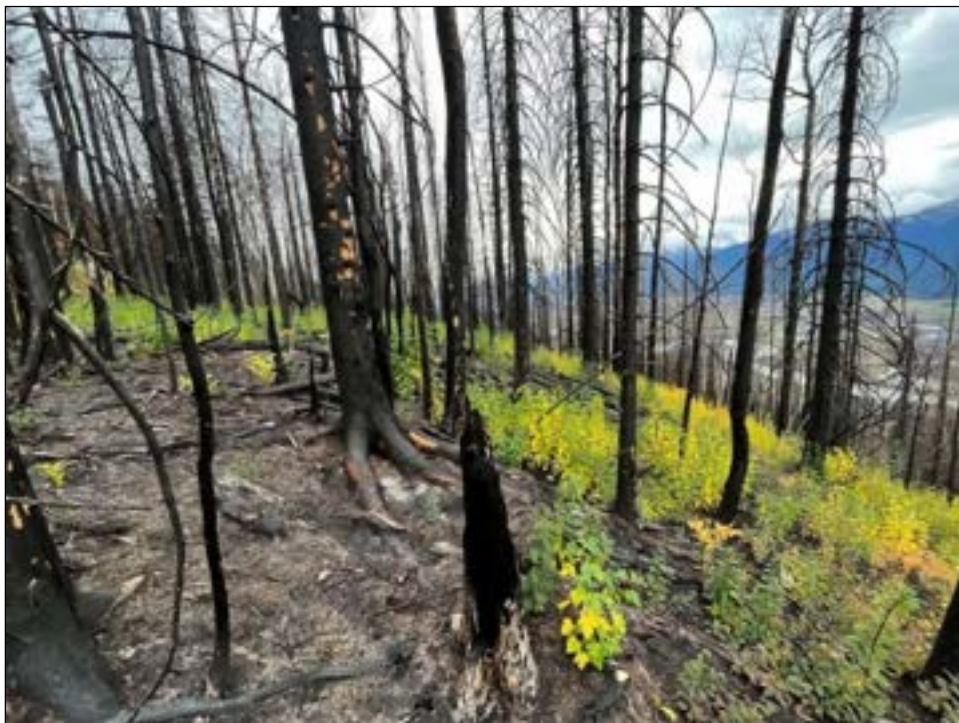
**Photo 3:** View looking southeast across the mid-slopes of Face Unit 1. Note the presence of organic material on and within the soil and the lack of fine ash on the ground; this site was observed to have low soil burn severity. Significant vegetative (shrub) regrowth has occurred since the Fire burned these slopes.

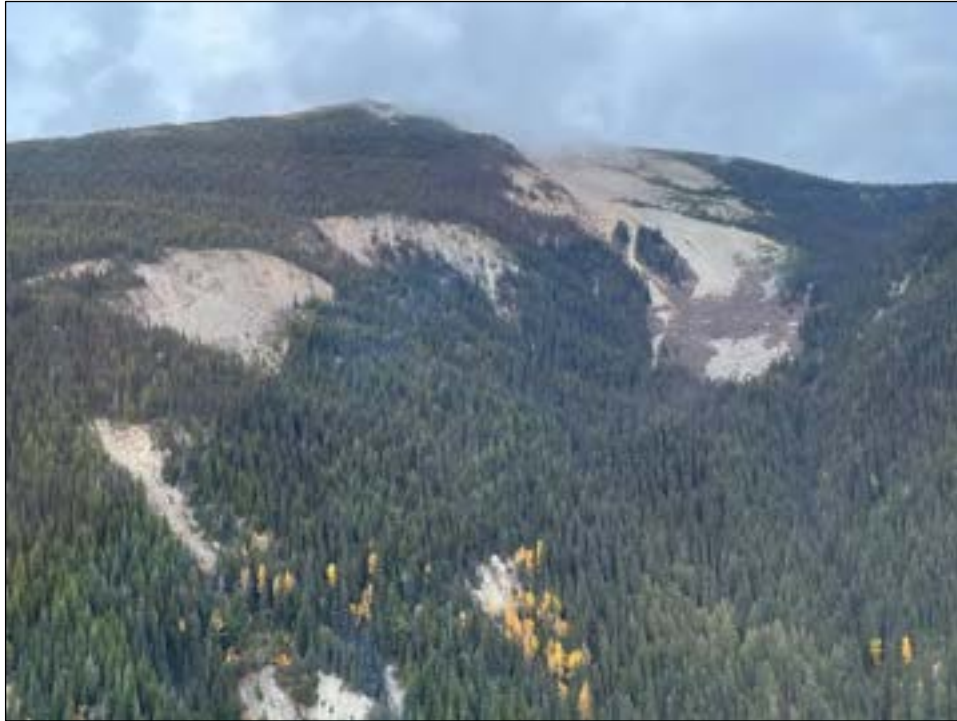
**Photo 4:** View of the upper reaches of Rainbow Creek watershed. A rubbly earthflow at right-centre of image is likely influenced by periglacial processes. Numerous other slump landslides in bedrock are visible in the headwaters.

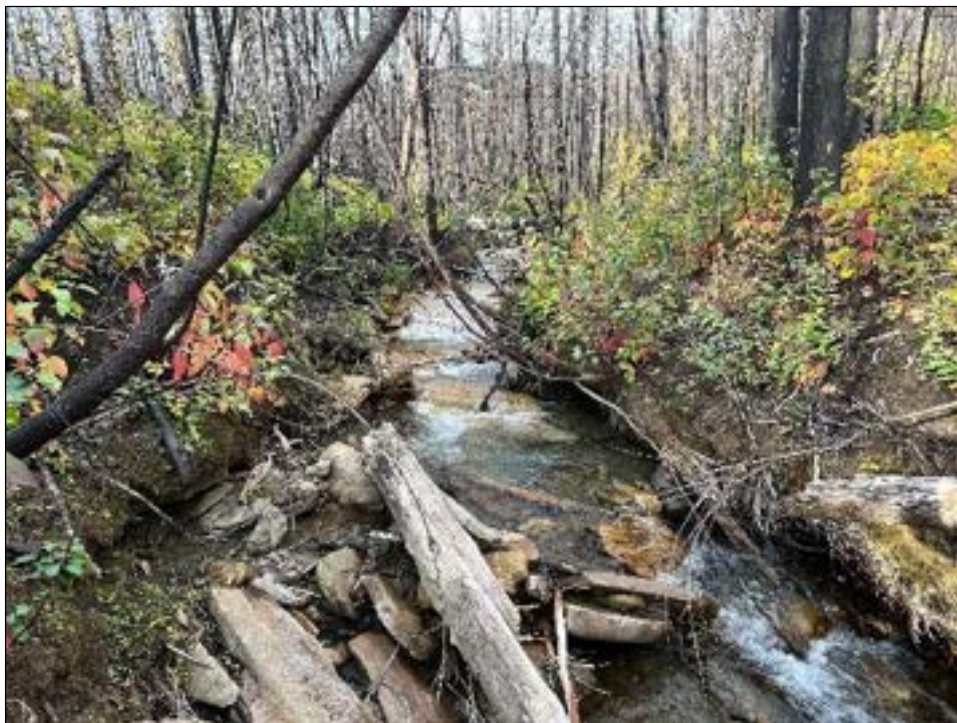
**Photo 5:** View of Rainbow Creek on the lower bench above the falls. Note the presence of large boulders embedded in the base of the channel. This reach was identified as high burn severity, but ground observations indicate burn severity was moderate. The channel gradient was 10% to 15%.

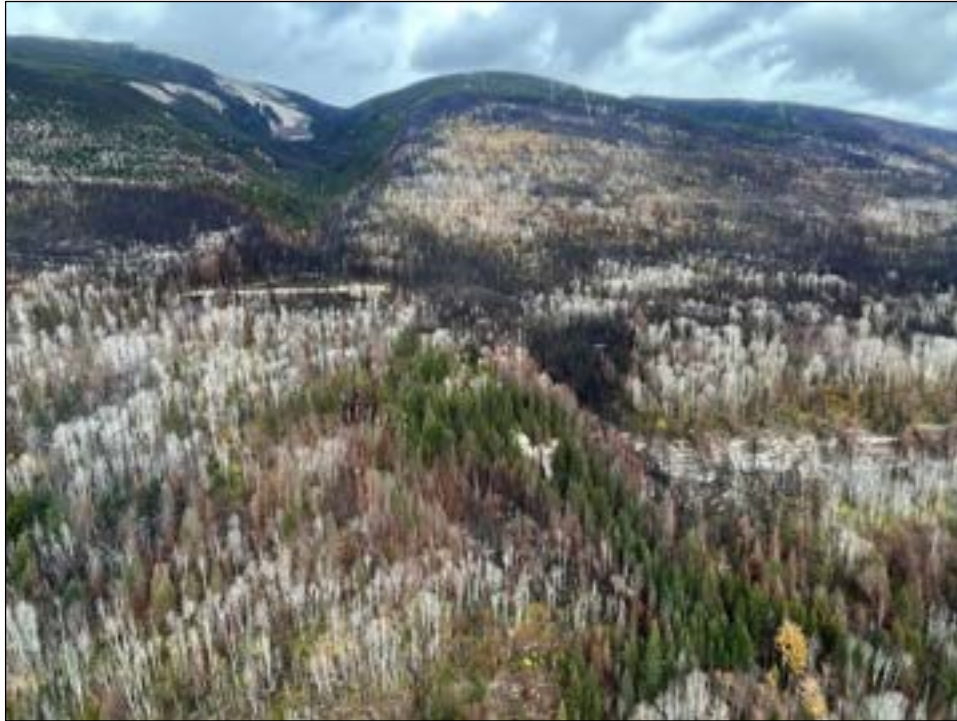
**Photo 6:** View of Rainbow Creek including the fluvial fan at bottom right, the moderately steep escarpment with waterfall at centre, the low gradient bench above the escarpment, and the unburned and confined steep upper valley.

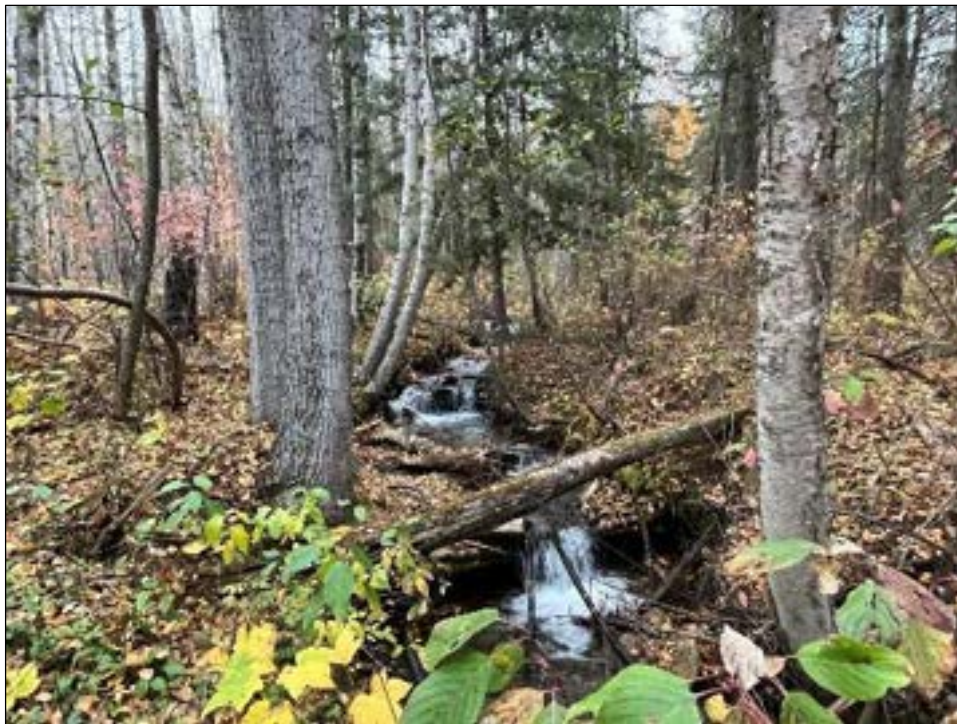
**Photo 7:** View of Rainbow Creek on the fluvial fan surface. Bed grain size has diminished from the reach above the falls and the channel is less deeply incised; the channel gradient is between 6% and 10%.

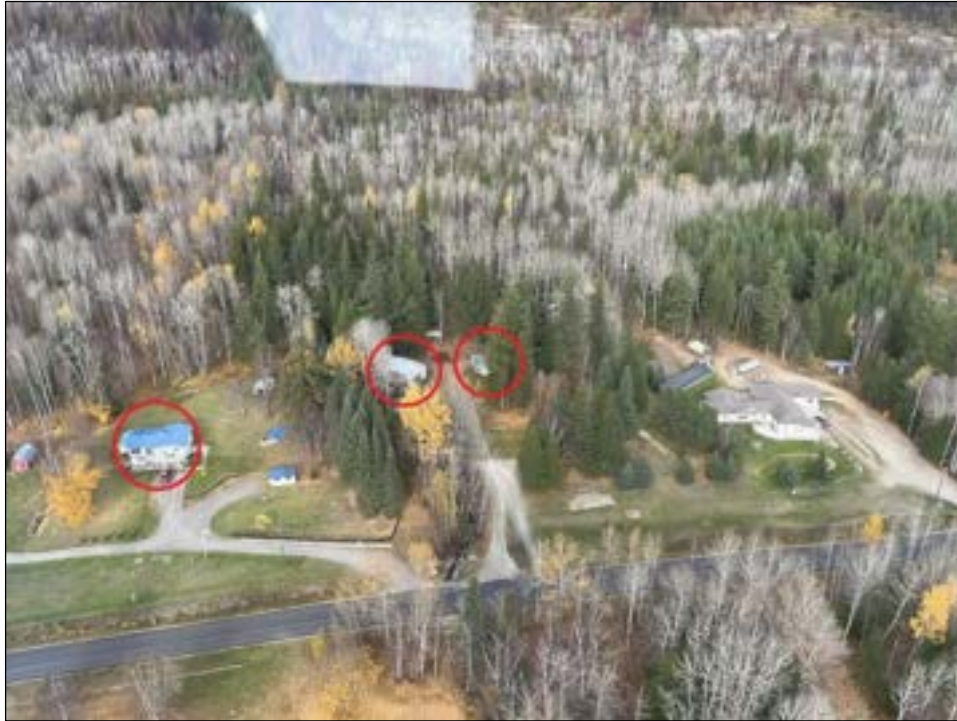
**Photo 8:** View of the residential area on the Rainbow Creek fluvial fan. The larger, blue-roofed structure (circled at left) is the residence at 520 Mountain View Road. The grey-roofed structure in the trees at centre is a garage (circled) for the residence at 470 Mountain View Road, which is visible immediately to the right (circled).

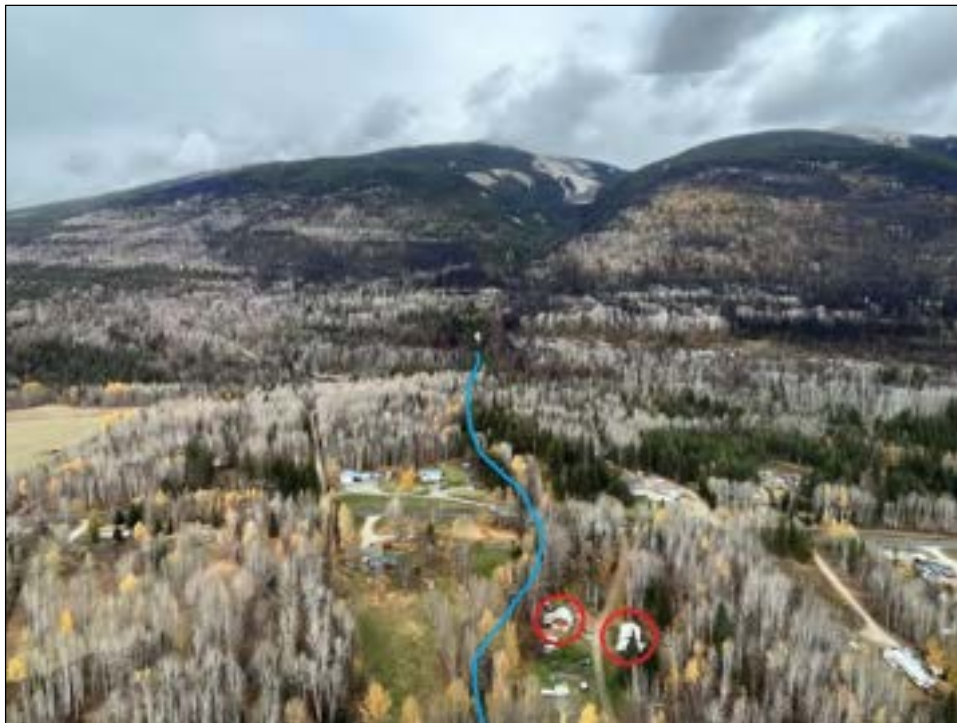
**Photo 9:** View of Rainbow Creek fluvial fan. A barn (circled, left) and the residence (circled, right) at 385 Koeneman Road are located close to the creek channel. The blue line is the trace of Rainbow Creek.

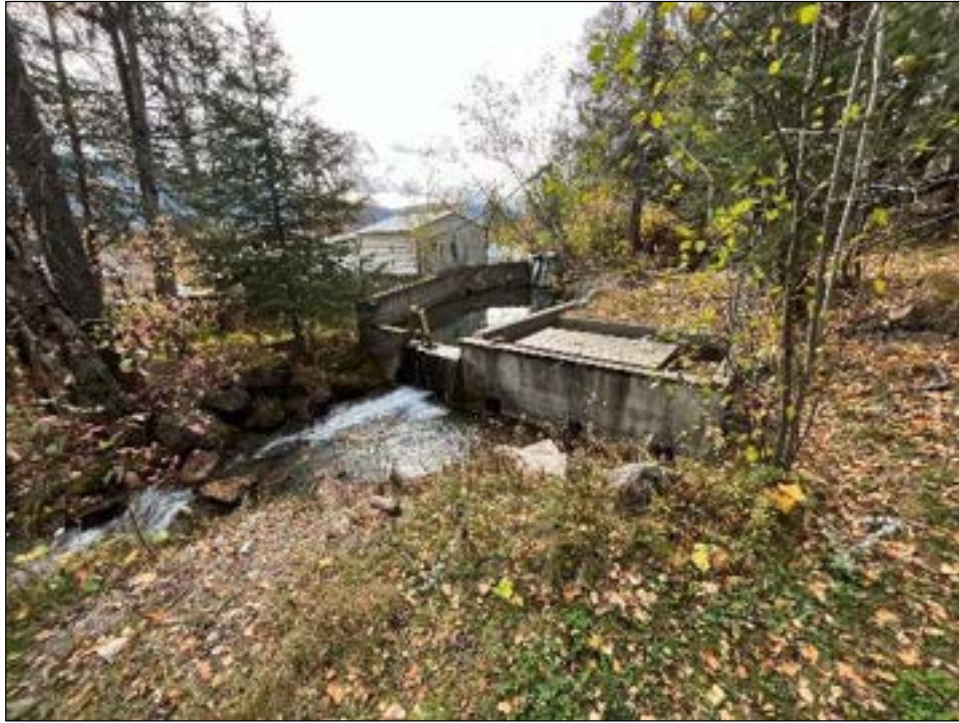
**Photo 10:** View west of the licenced water pond and intake structure on Rainbow Creek. Structure is located on the property line between the properties at 520 and 470 Mountain View Road.

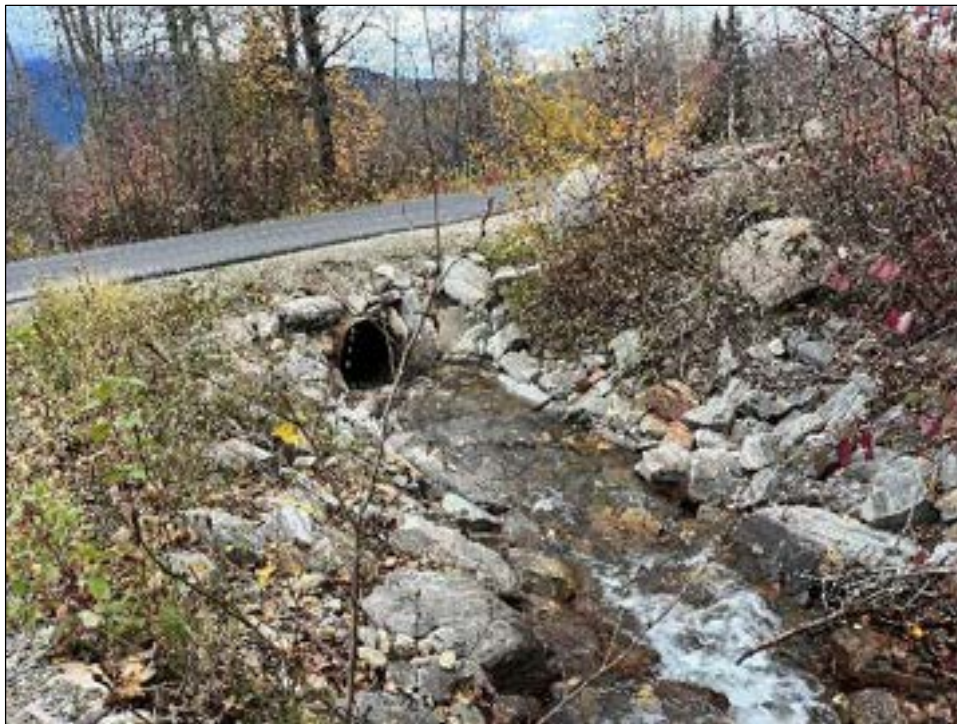
**Photo 11:** View of Rainbow Creek as it reaches Mountain View Road and passes under the road through a 1000 mm corrugated steel pipe culvert. Boulders are placed to armour the inlet.

- Inspected and maintained at least annually for the next five years.
- Reviewed to determine the efficacy to be able to convey the post-wildfire flows.

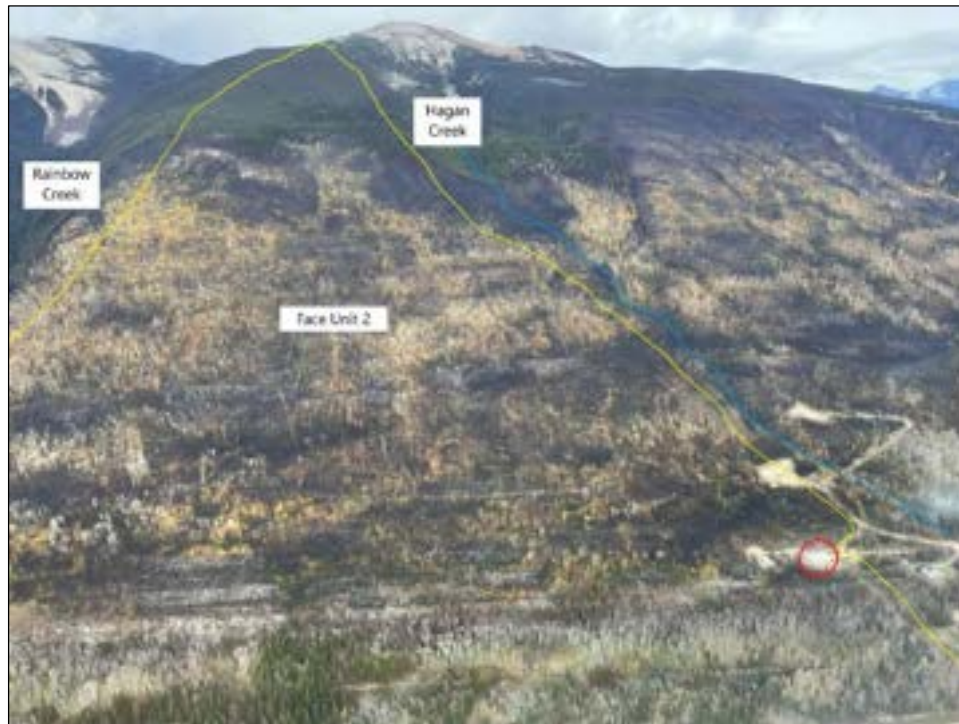
**Photo 12:** Wide view of Face Unit 2, outlined in yellow. Upper Rainbow Creek watershed is at left of image; Hagan Creek is marked with a blue line at right centre. The shallow draws within Face Unit 2 are difficult to discern in the image due to color variation of the vegetation. The residence at bottom right of image is located within the Hagan Creek watershed. The large outbuilding (circled) is within Face Unit 2.

The owner of the outbuilding at 3100 McBride Highway 16 E should consider constructing a deflection berm to protect this structure.

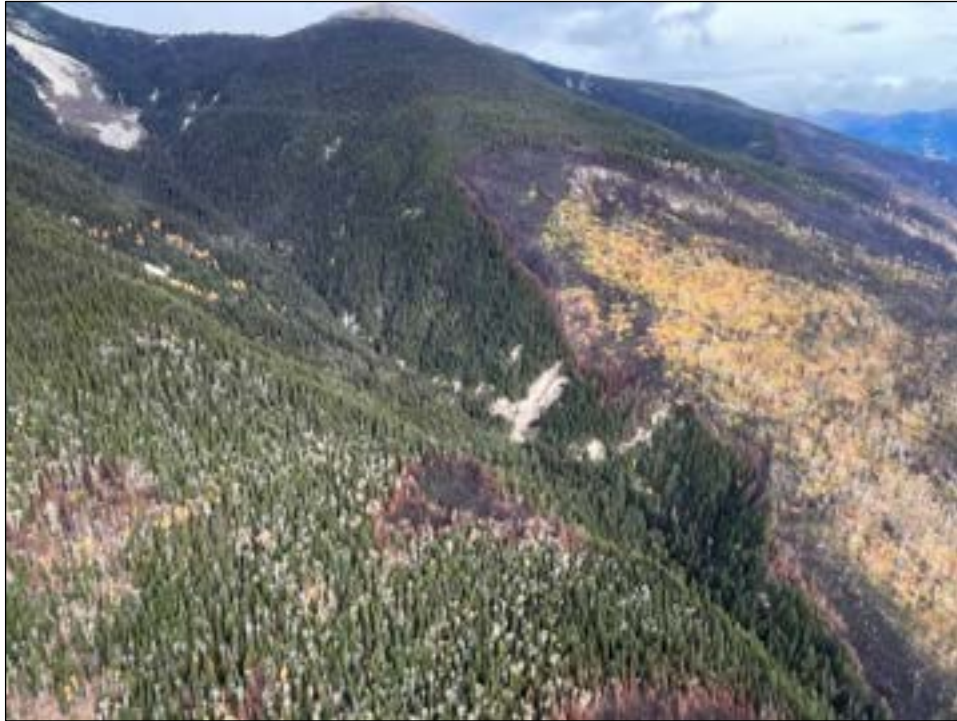
**Photo 13:** View of the upper end of Face Unit 2 with the large, shallow landslide outlined with exposed light brown bedrock in the headscarp at right centre on the open slope. Rainbow Creek, in the foreground, has several pre-existing, side-slope landslides leading into the main valley.

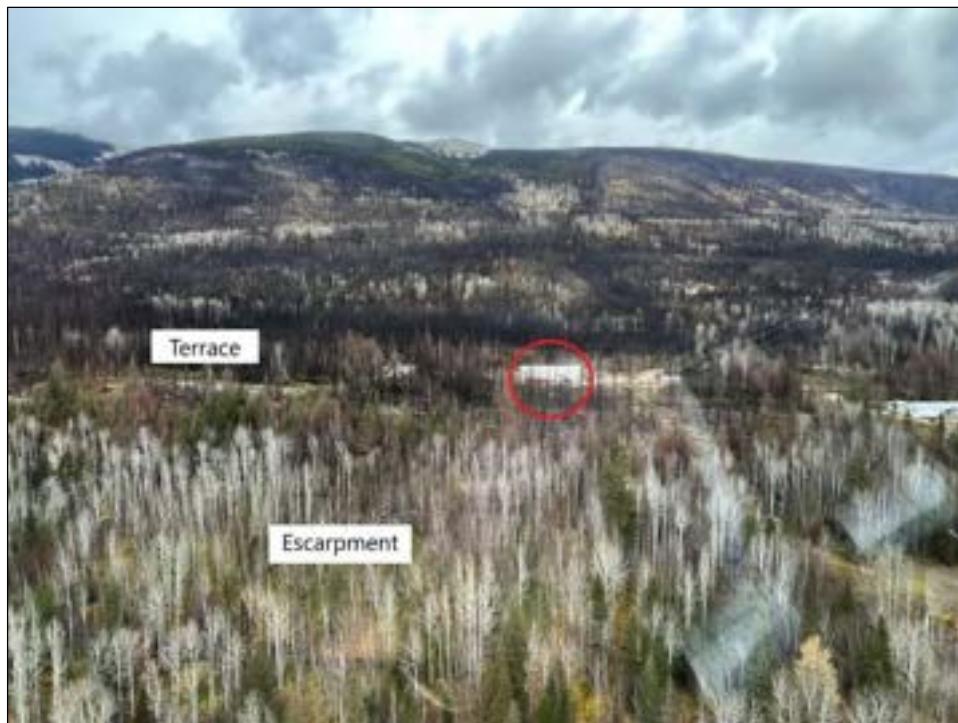
**Photo 14:** View of the lower slope in Face Unit 2. The residence at bottom right is located in the Hagan Creek watershed. The large outbuilding at centre is accessed by HG Road from the right side of image. The building is on a wide, gently sloped bench immediately above the moderately steep escarpment face.

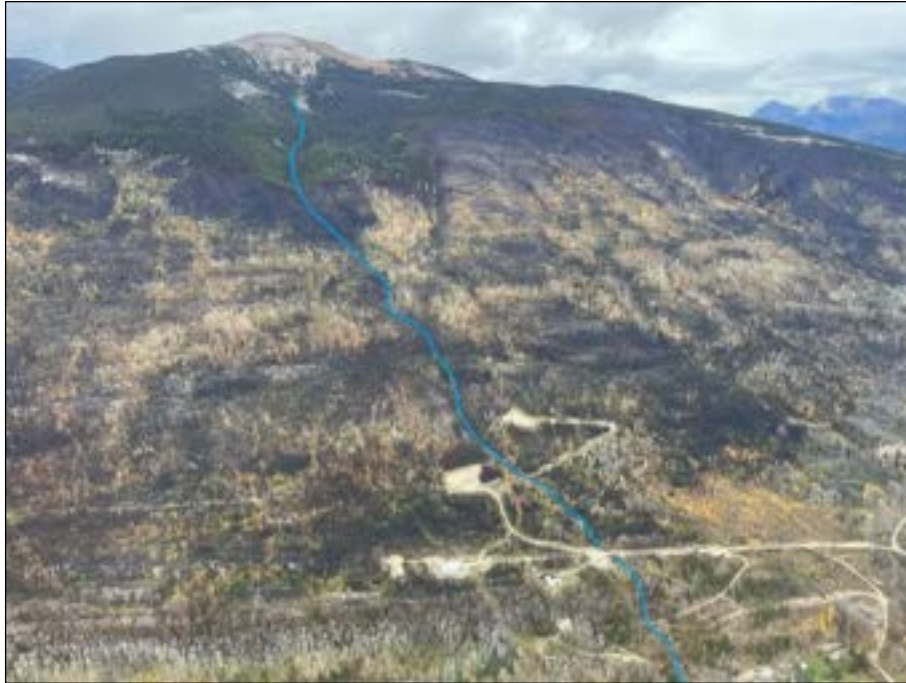
**Photo 15:** View of the Hagan Creek watershed. Landslides appear active in the upper watershed on the face of Mount Teare. The trace of Hagan Creek is marked in blue.

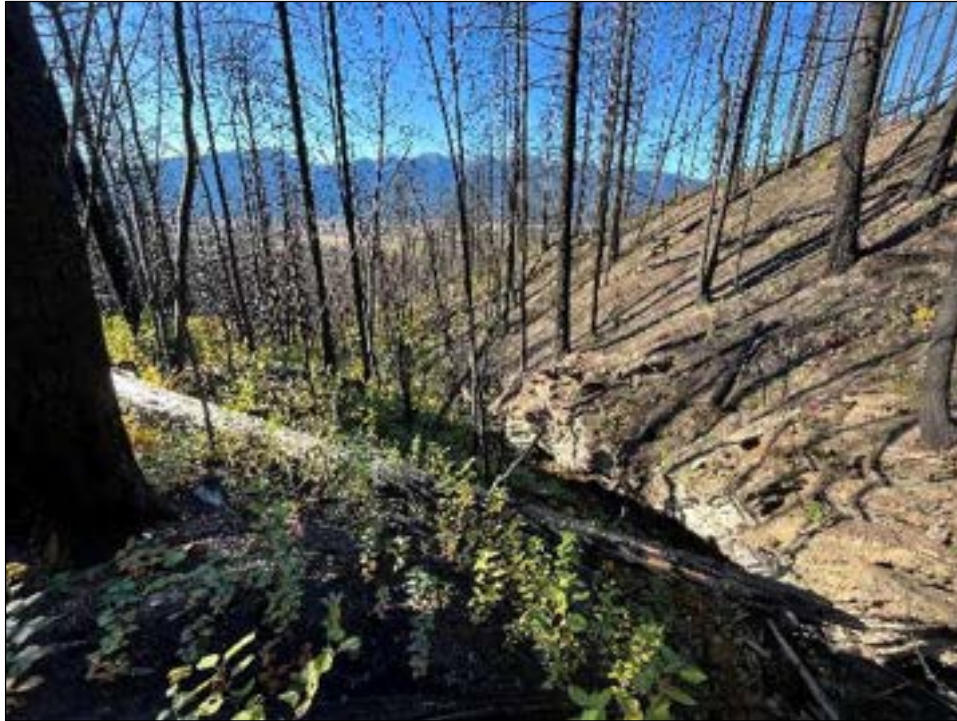
**Photo 16:** View of the Hagan Creek channel as it approaches the lower bench. The channel is deep and confined, but downslope from here, the creek loses confinement on the gentler slopes.

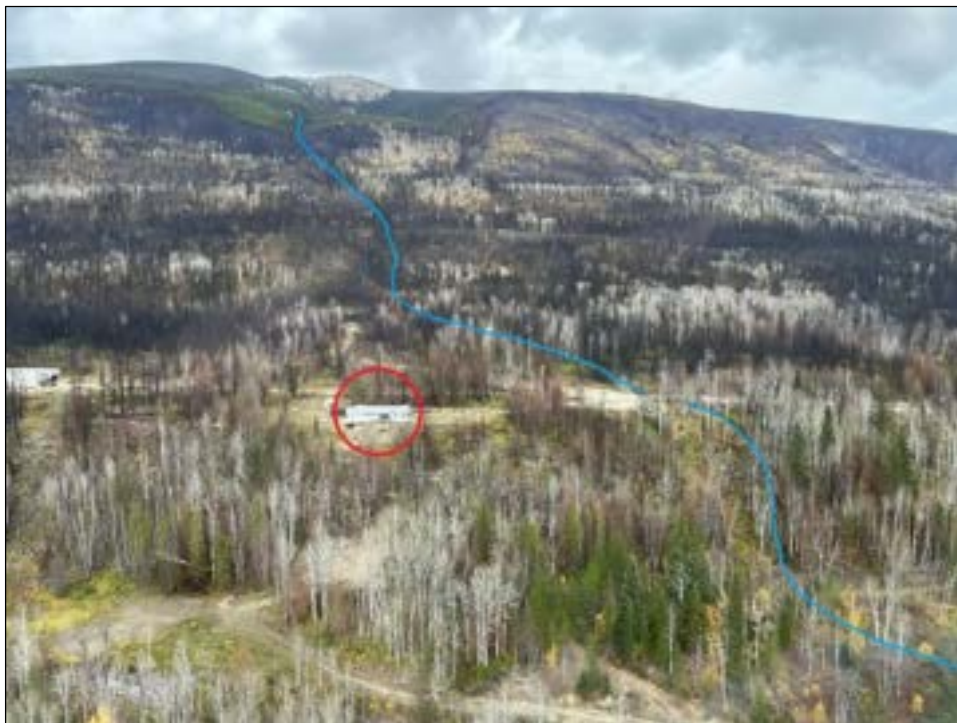
**Photo 17:** View of the residence at 3100 McBride Highway 16 E (circled) on the north side of Hagan Creek. The creek channel crosses an upper road (not visible) and the HG Road through culverts. The creek has the potential to avulse and be diverted towards the residence.

For the long-term, a flood hazard assessment should be completed to determine whether protection/stabilization measures along the creek channel are necessary to mitigate the risk from the increased magnitude of streamflow. If required, they should be installed.

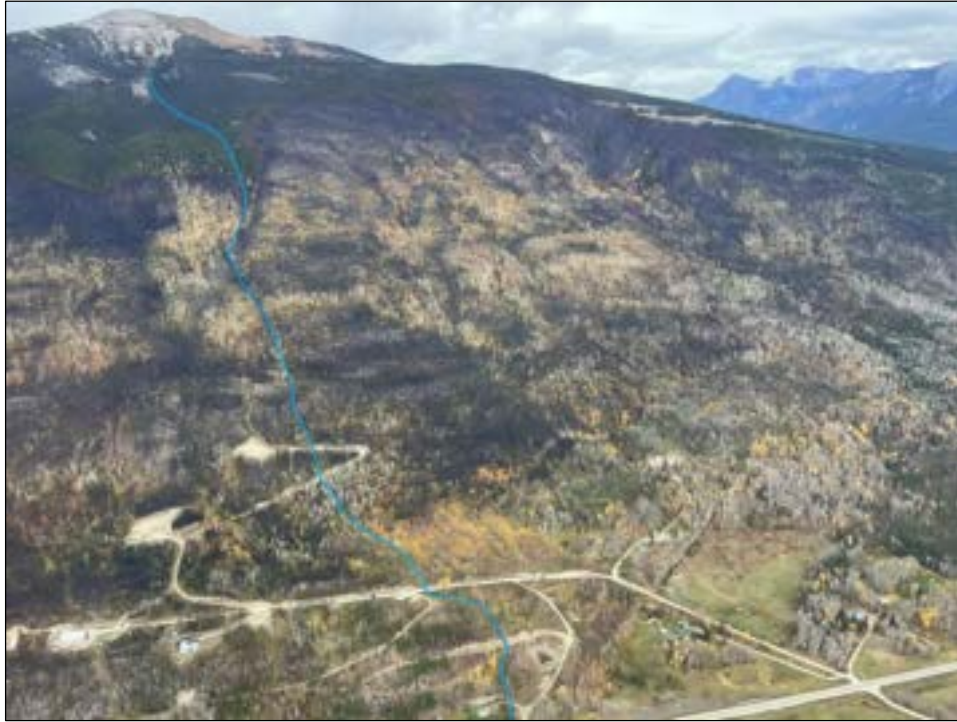
**Photo 18:** View of the upper reaches of the Gort Creek watershed. Landslides appear active in the upper watershed on the face of Mount Teare, but these are unlikely to move far downslope due to the moderate gradient slopes. The trace of Gort Creek is marked in blue.

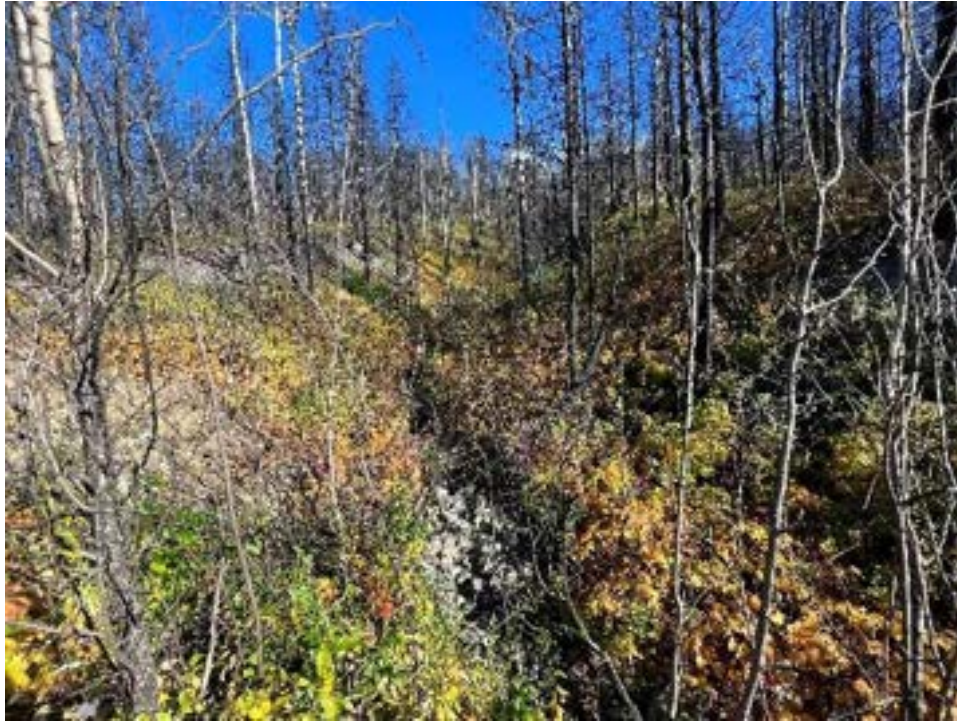
**Photo 19:** View of Gort Creek channel above the upper access road. The creek is confined in a deep draw. The active channel has a coarse cobble-gravel base.

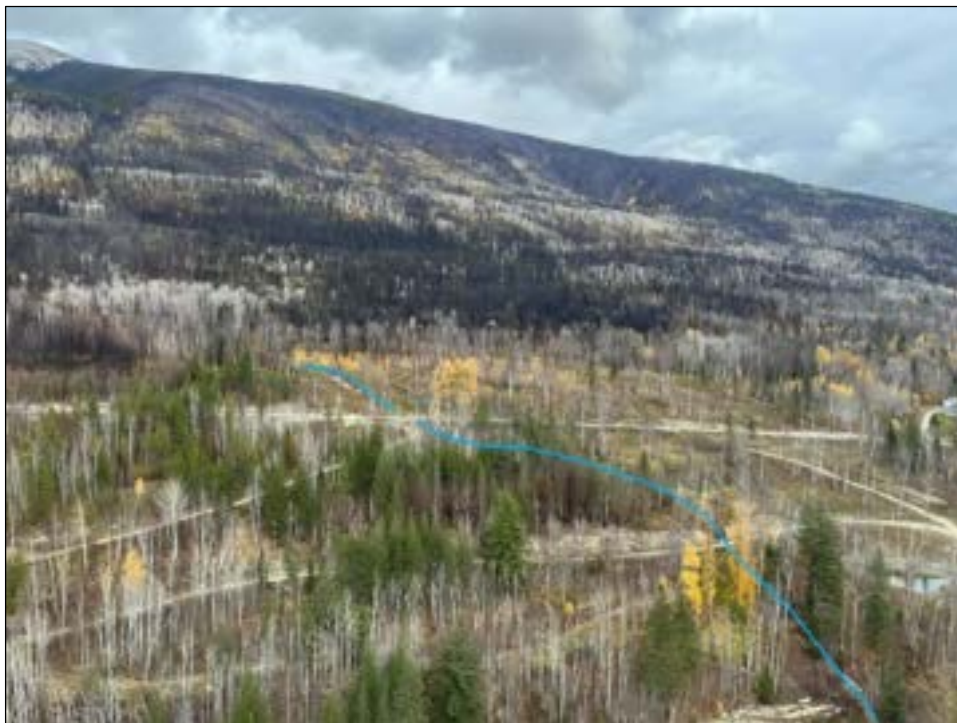
**Photo 20:** View of lower Gort Creek and the road system that crosses the lower watershed. The trace of lower Gort Creek is marked in blue. The diversion pond is visible at lower right. The residence at 3192 McBride Highway 16 E is out of image at bottom right.

For the long-term, a flood hazard assessment should be completed to determine whether protection/stabilization measures along the creek channel are necessary to mitigate the risk from the increased magnitude of streamflow. If required, they should be installed.

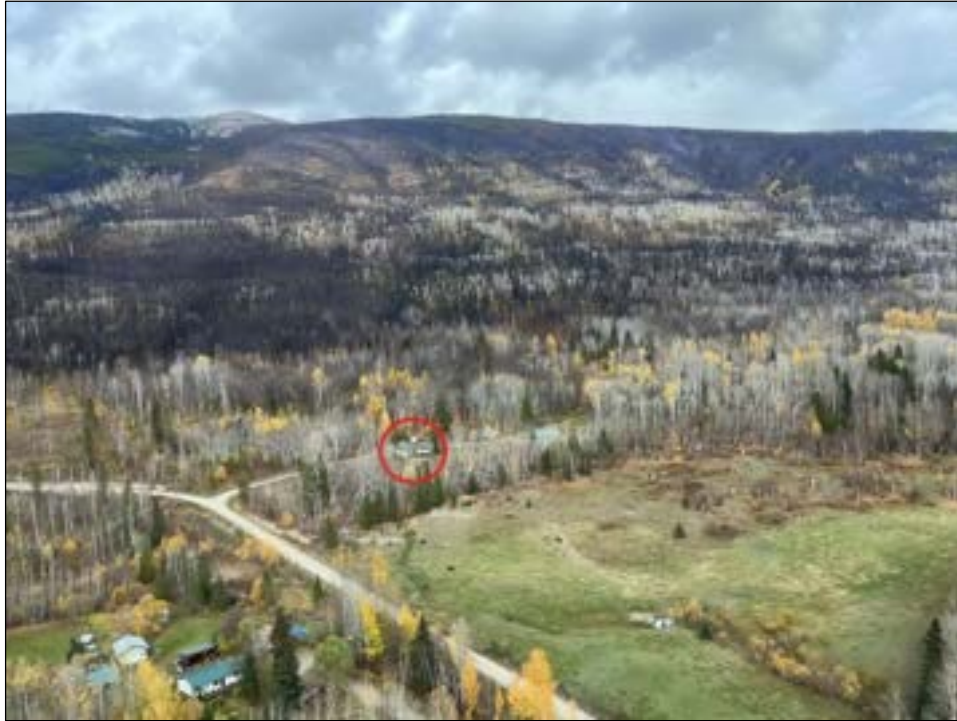
**Photo 21:** View looking north at Face Unit 3. The residence at 3270 McBride Highway 16 E is located at centre. Immediately upslope of the residence the slopes are mapped as having a low or moderate burn severity.

For the long-term, a landslide hazard assessment should be completed to determine whether protection/stabilization measures across the slope are necessary to mitigate the risk from landslides. If required, they should be installed.

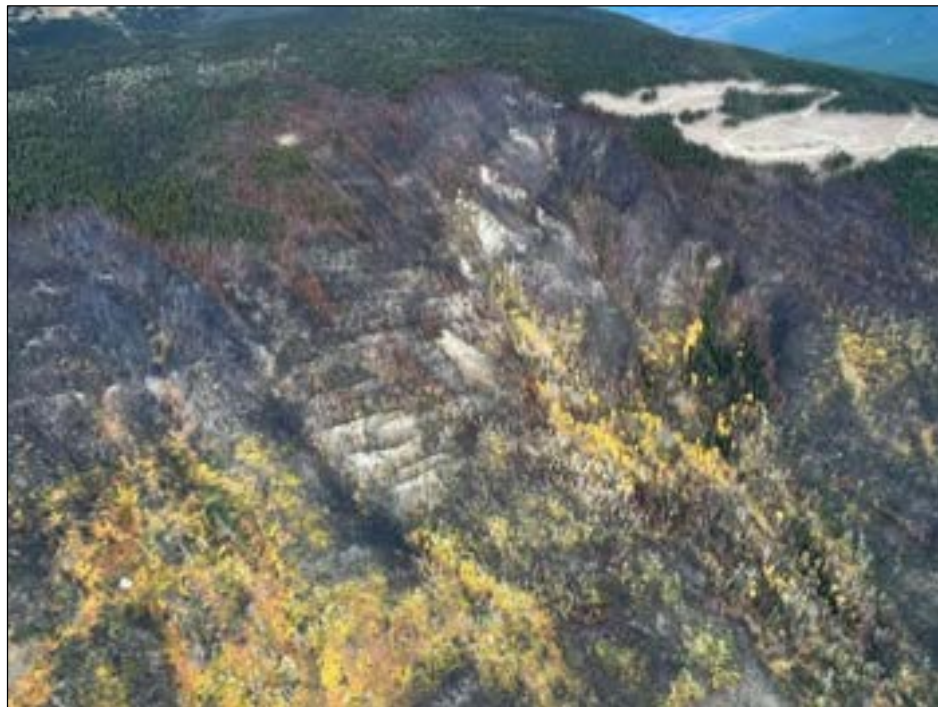
**Photo 22:** View of the steep gullied slopes in the upper part of the Teare Creek watershed. Avalanche and debris flow paths are common, as are talus cones and open slope landslides.

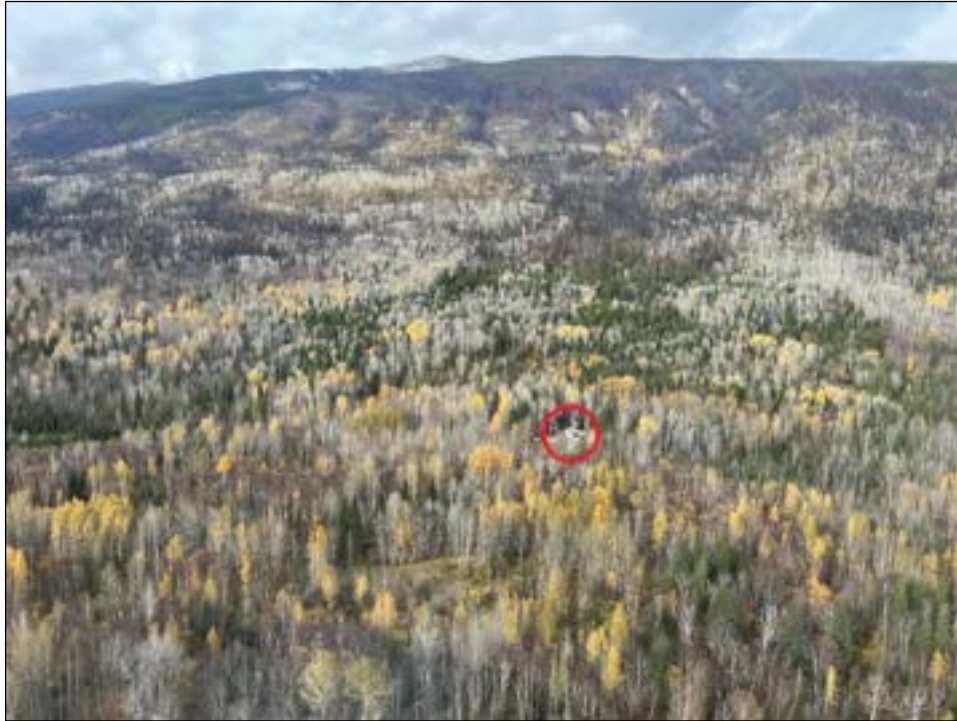
**Photo 23:** View of the Teare Creek watershed. The steep, gullied slopes of the upper watershed are visible at the top of the image. The residence at 3496 Laing Road is circled.

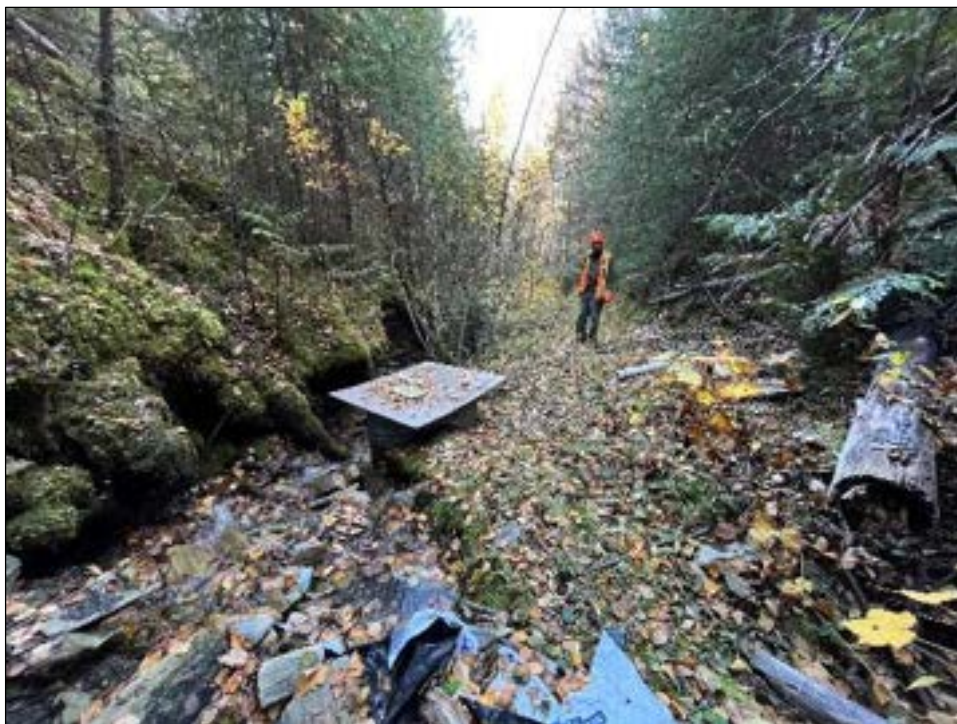
**Photo 24:** View of the licensed water intake structure located on the upper fan of Teare Creek.

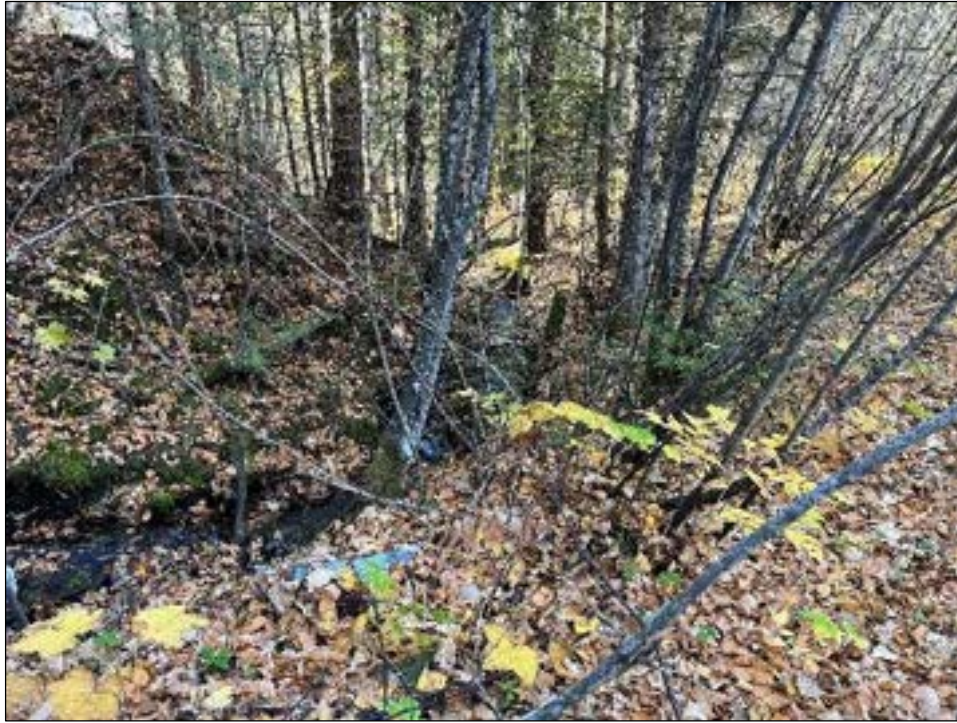
**Photo 25:** View of Teare Creek on the fan at the base of the slope; flow has been diverted to the east in an excavated channel. During a flood, the creek could overtop its banks and flow downslope towards the residence.

For the long-term, a flood hazard assessment should be completed to determine whether protection/stabilization measures along the creek channel are necessary to mitigate the risk from the increased magnitude of streamflow. If required, they should be installed.
