## **Hydrologic and Geomorphic Assessment of the Dore River**

March 11, 2021 | Revision 2

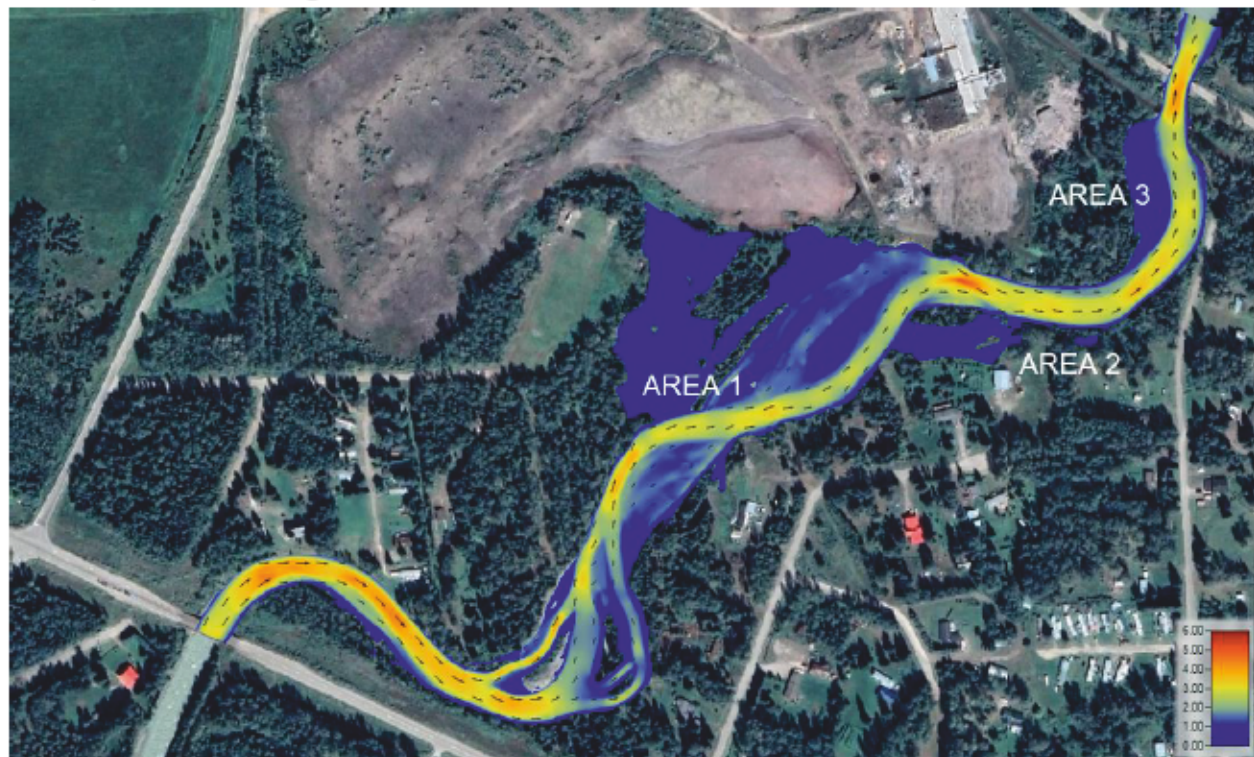
### Watershed Geomorphic Overview

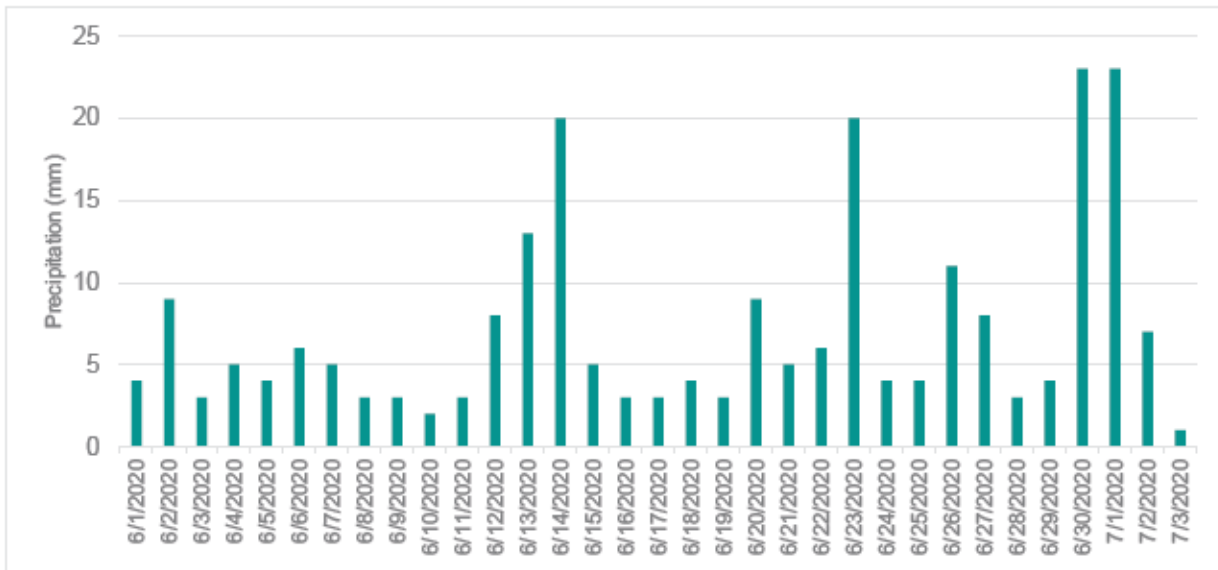
Figure 2 Daily Precipitation - June 1, 2020 to July 2, 2020 - McBride Climate Station

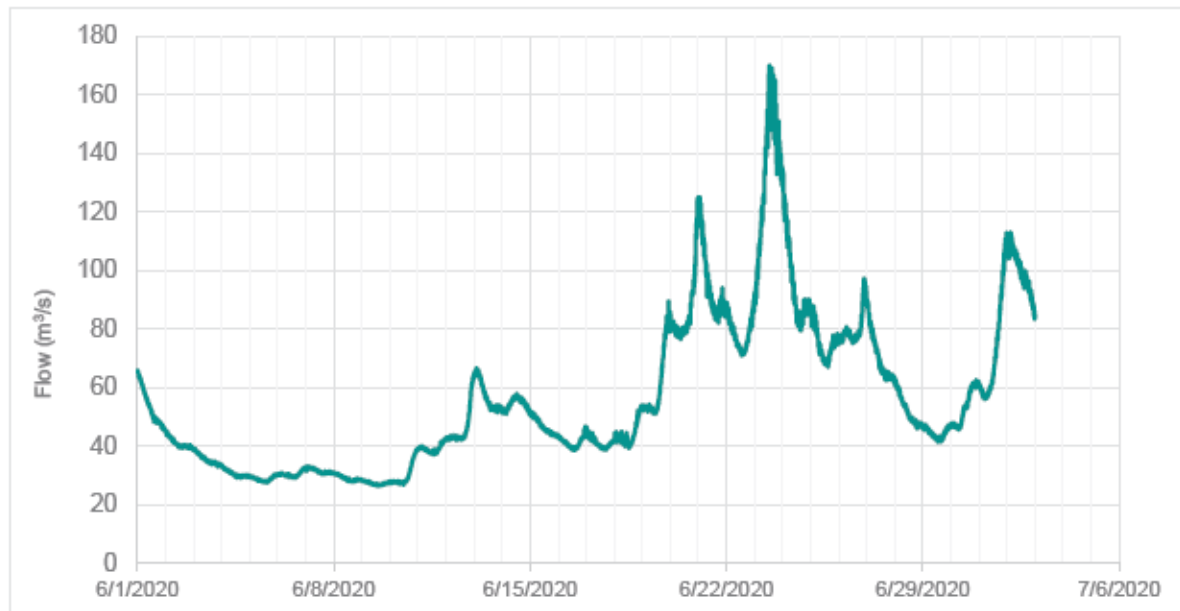
Figure 3 Flow (Preliminary) - June 1, 2020 to July 2, 2020 – WSC #08KA001: Dore River at McBride

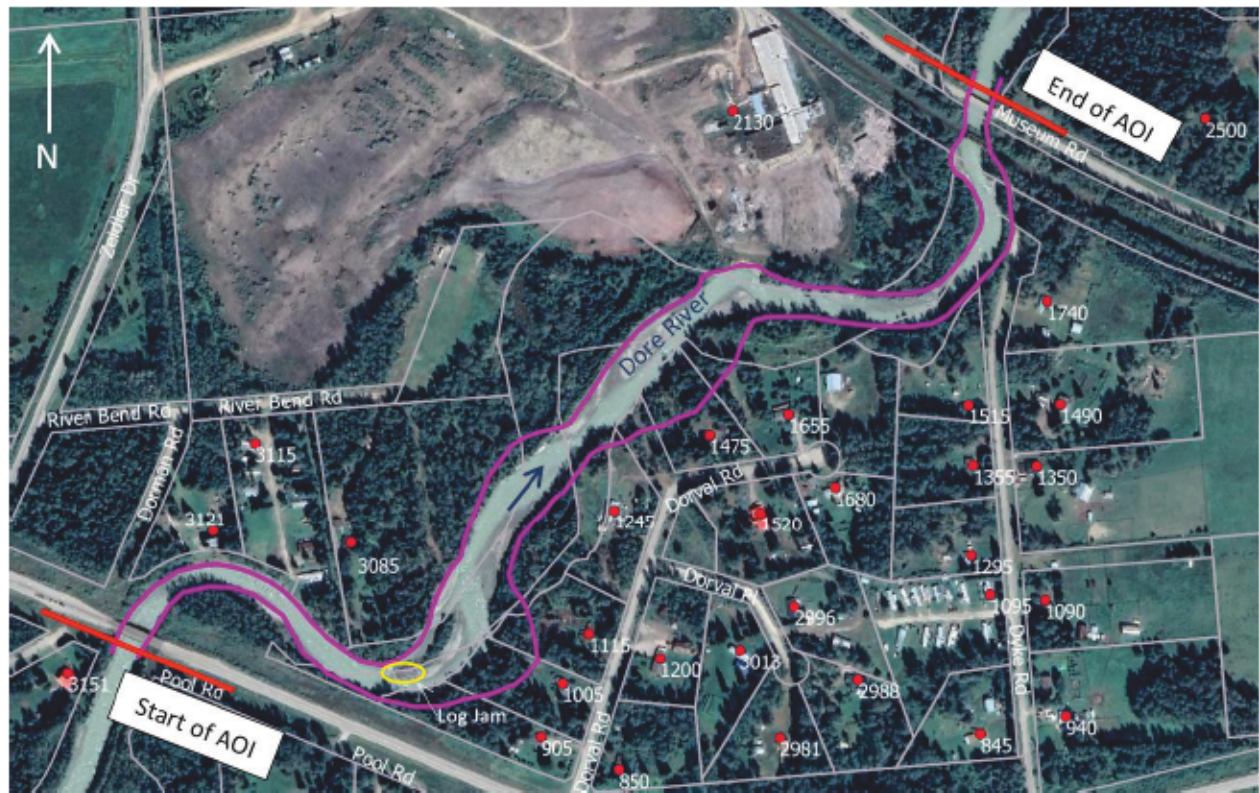
Figure 4: New channel extents overlain on Google satellite imagery of the pre-flood channel.

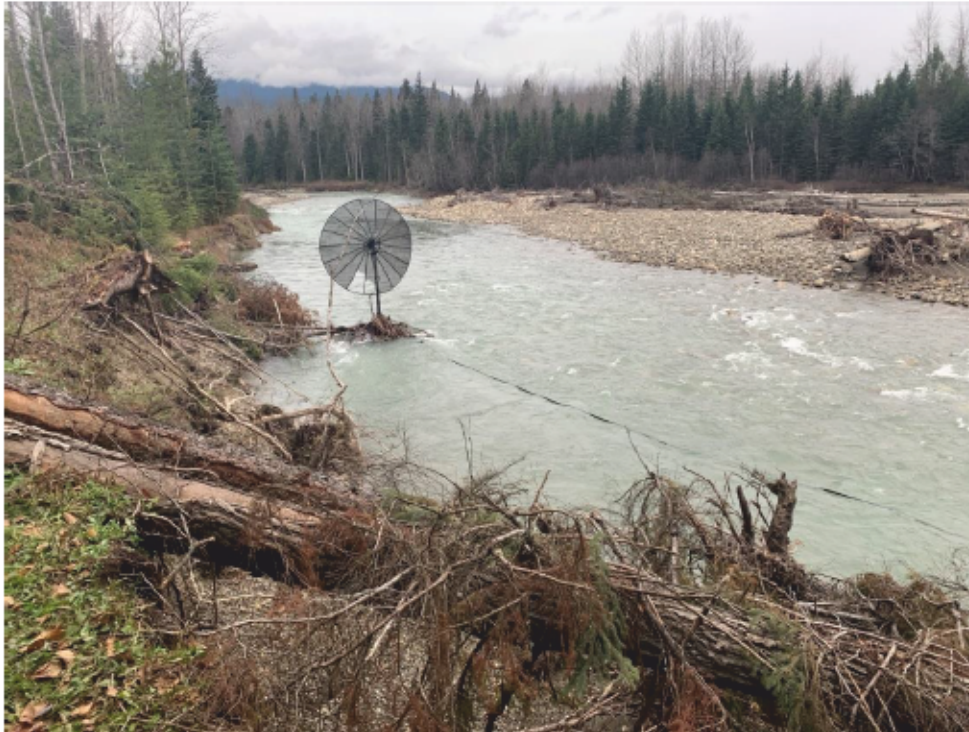
*Figure 10 Looking out toward Dore River from banks of the 1475 Dorval Road property (Photo taken November 3, 2020)*

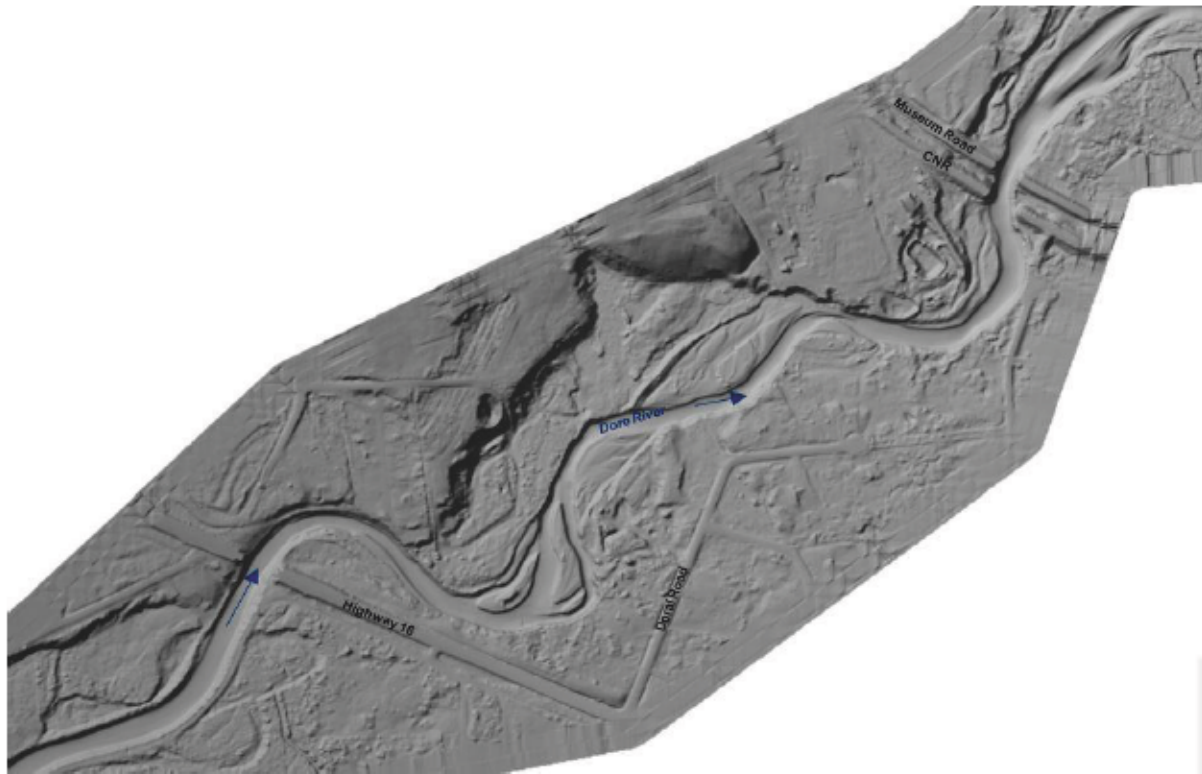
*Figure 13 Digital Elevation Model (DEM). Based on LiDAR and Channel Survey (0.2m x 0.2m grid)*

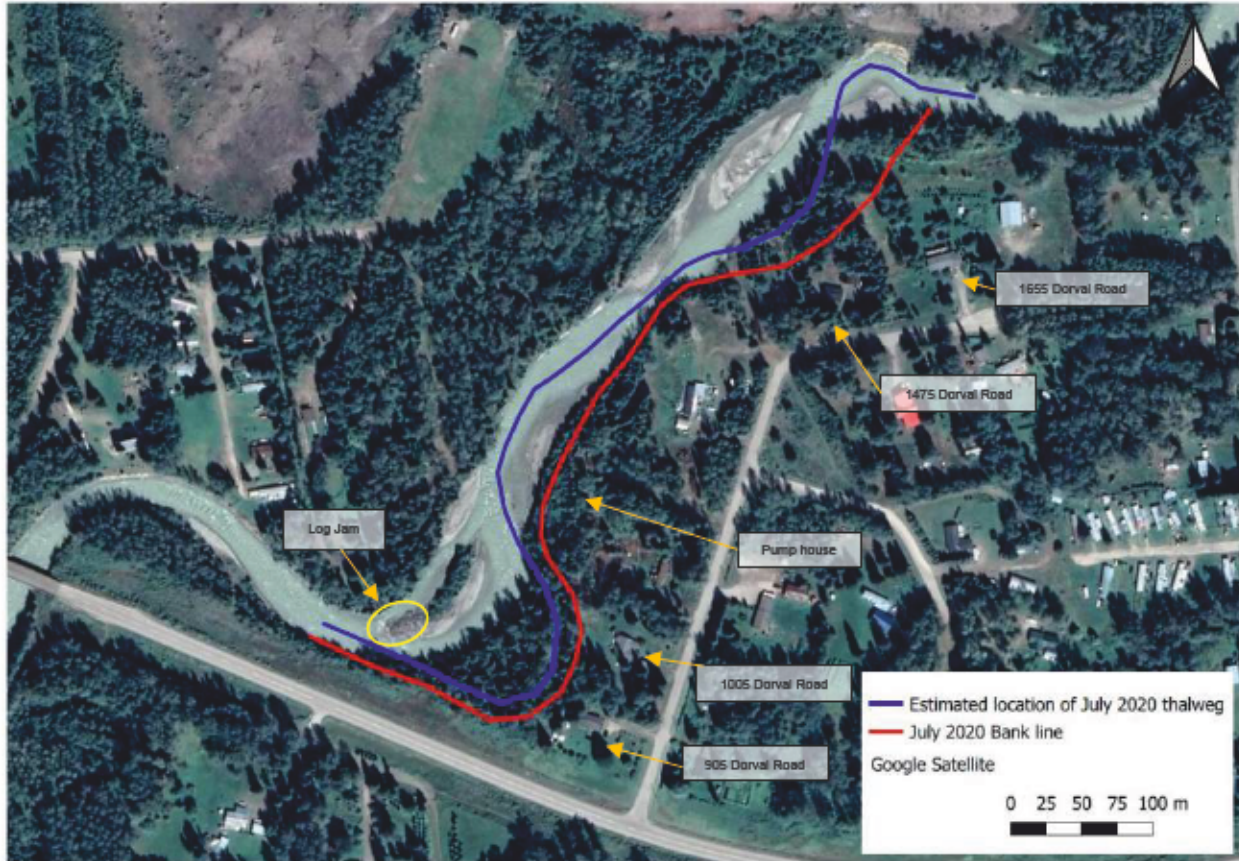
Figure 1: Overview map of area showing estimated location of the new right bank (red) and estimated location of the river thalweg (blue)

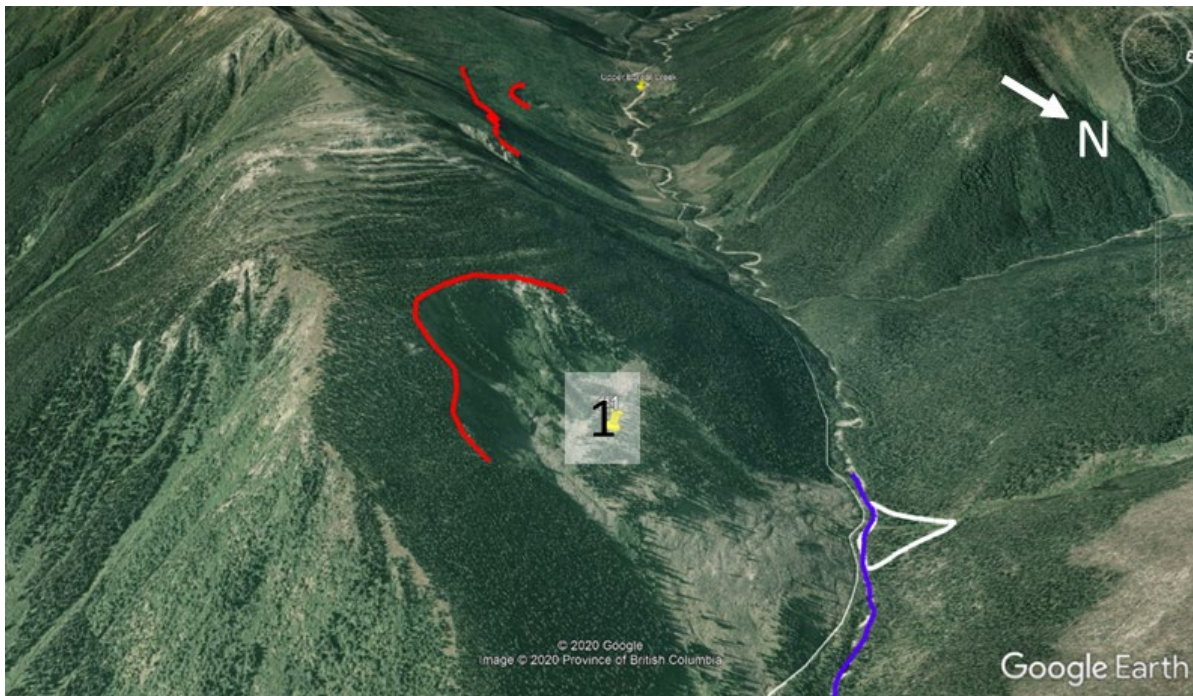
**Figure 2-1. Google Earth image of Upper Boreal Creek sub-tributary of Dore River Watershed (Location #1 on Drawing 01) The red line indicates the crest of a slope movement feature that has pushed Upper Boreal Creek towards the north side of the creek (section delineated in blue). A steep creek fan (white outline) is also confining the main stem from the north.**

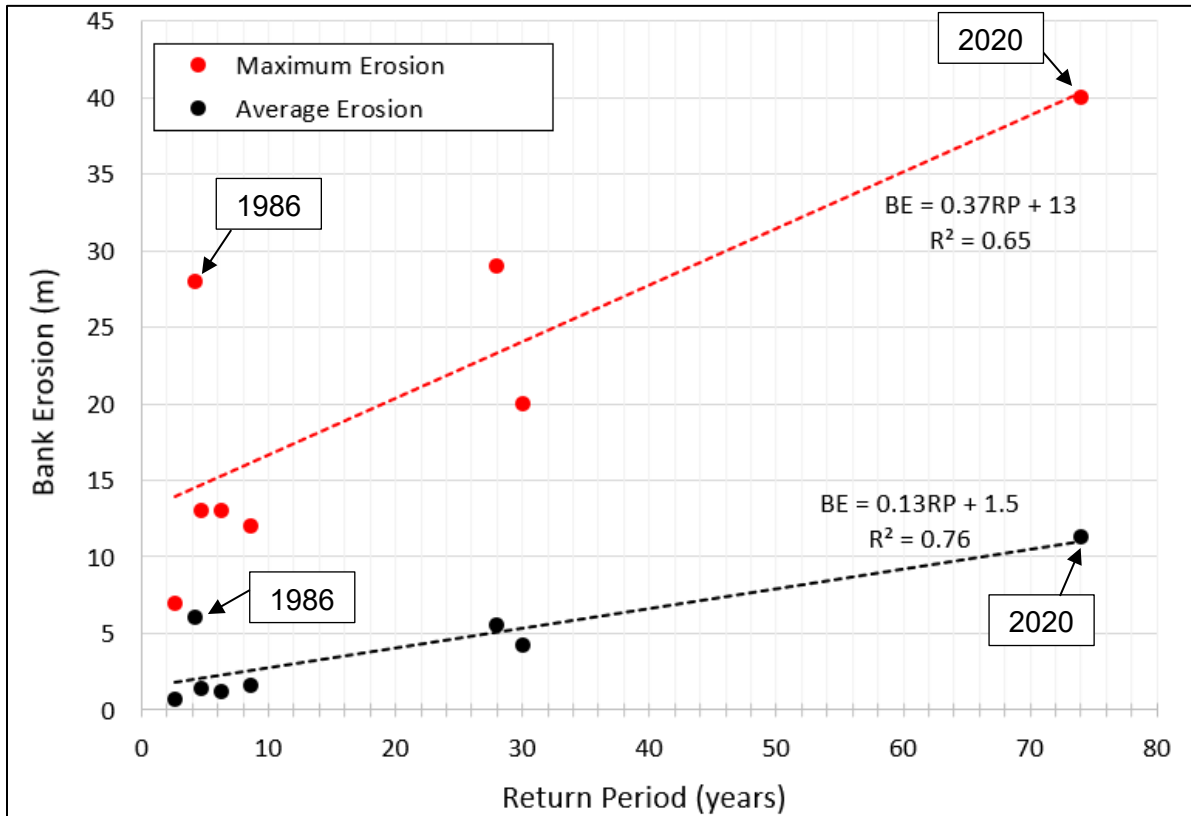
Figure 3-2. Average and maximum erosion compared with flood return period for the years 1958 to 2020.

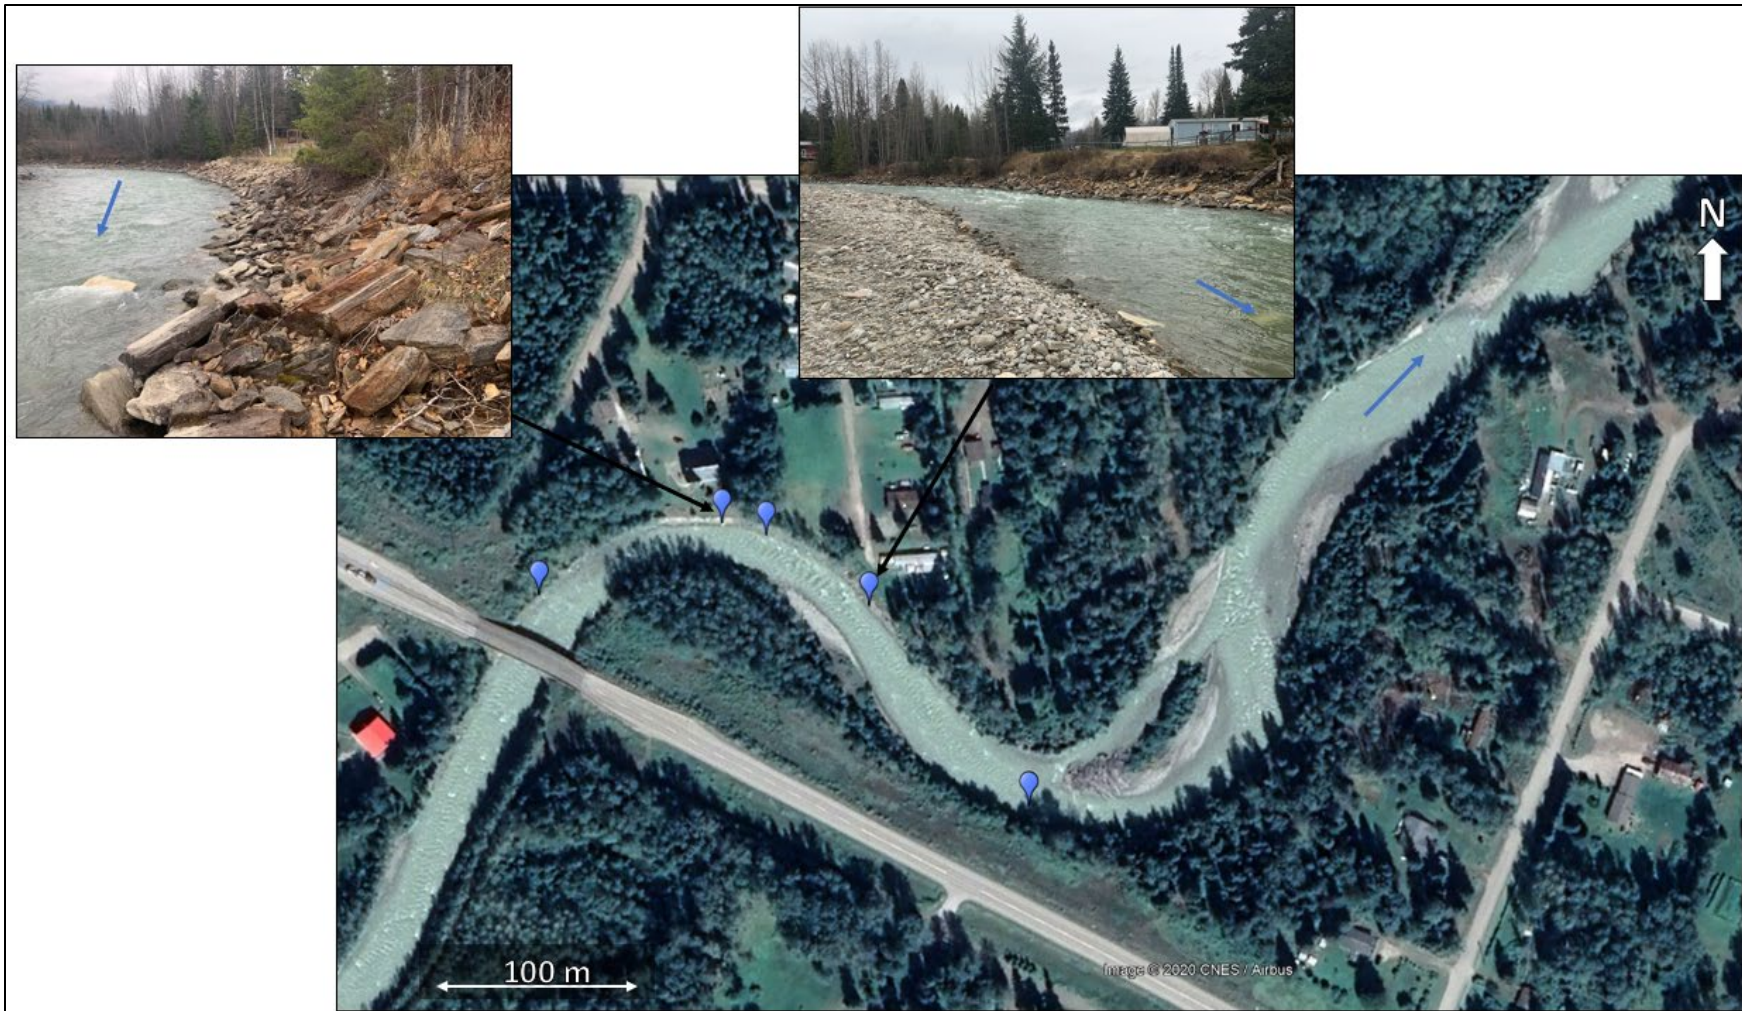
**Figure 3-4. Riprap locations observed during a post-flood site visit by McElhanney are shown (blue markers) with flow direction indicated by the blue arrows. Imagery source: inset photographs obtained by McElhanney on November 3, 2020, and background imagery from Google Earth, August 19, 2019.**

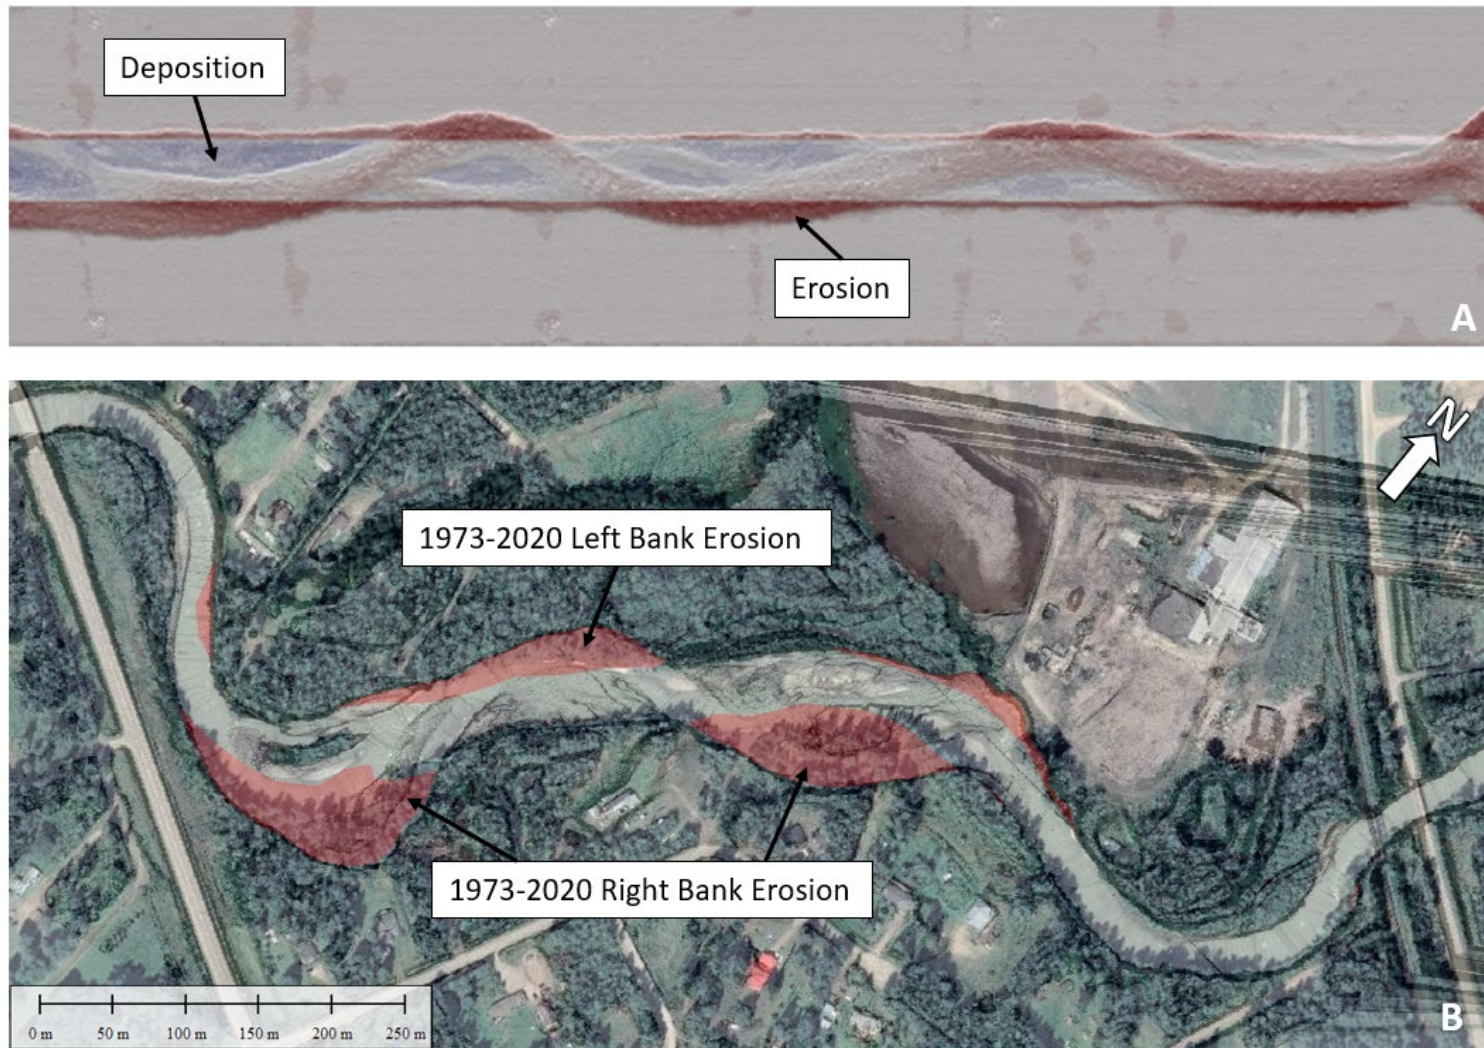
Figure 3-5. In A) red polygons represent erosion and blue polygons show deposition following flooding in experiments conducted by Eaton et al. (2020). In B) red polygons indicate erosion observed between 1973 and 2020. Imagery source: Google Earth, August 19, 2020, and October, 2020 lidar DEM hillshade provided by McElhanney.

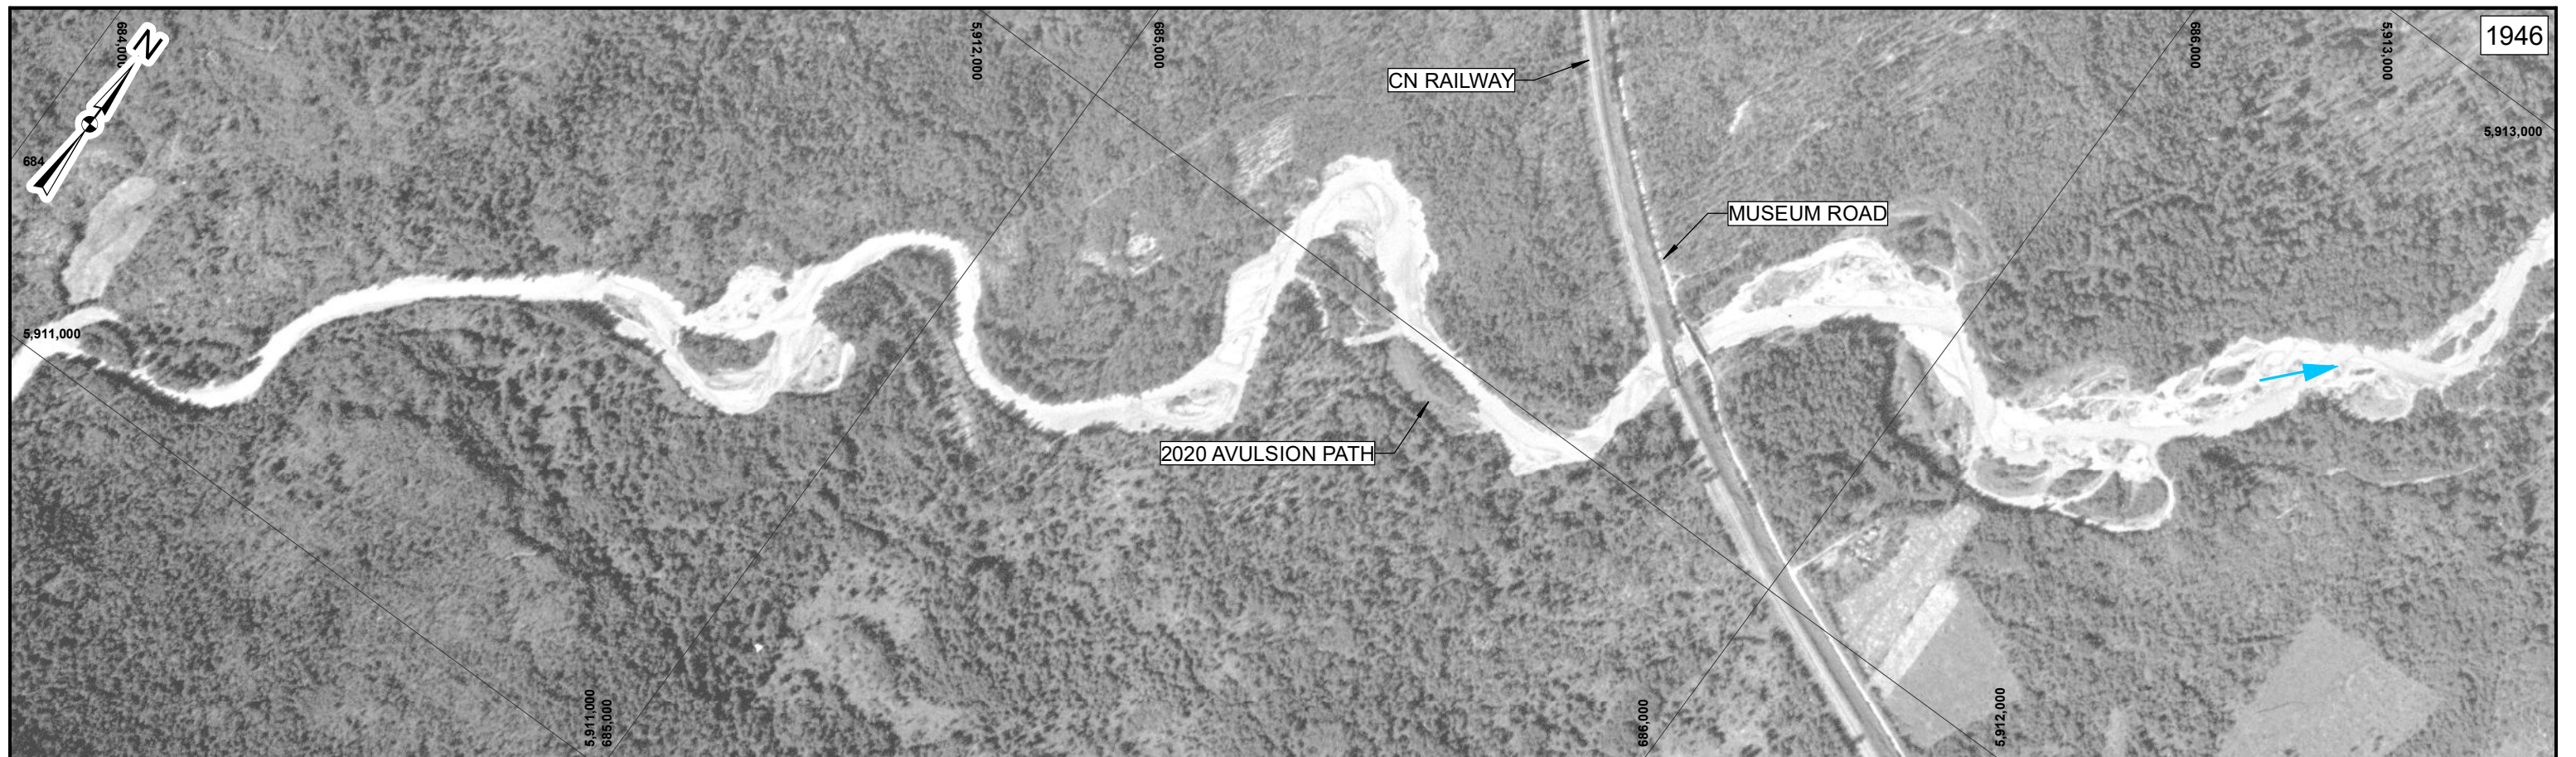
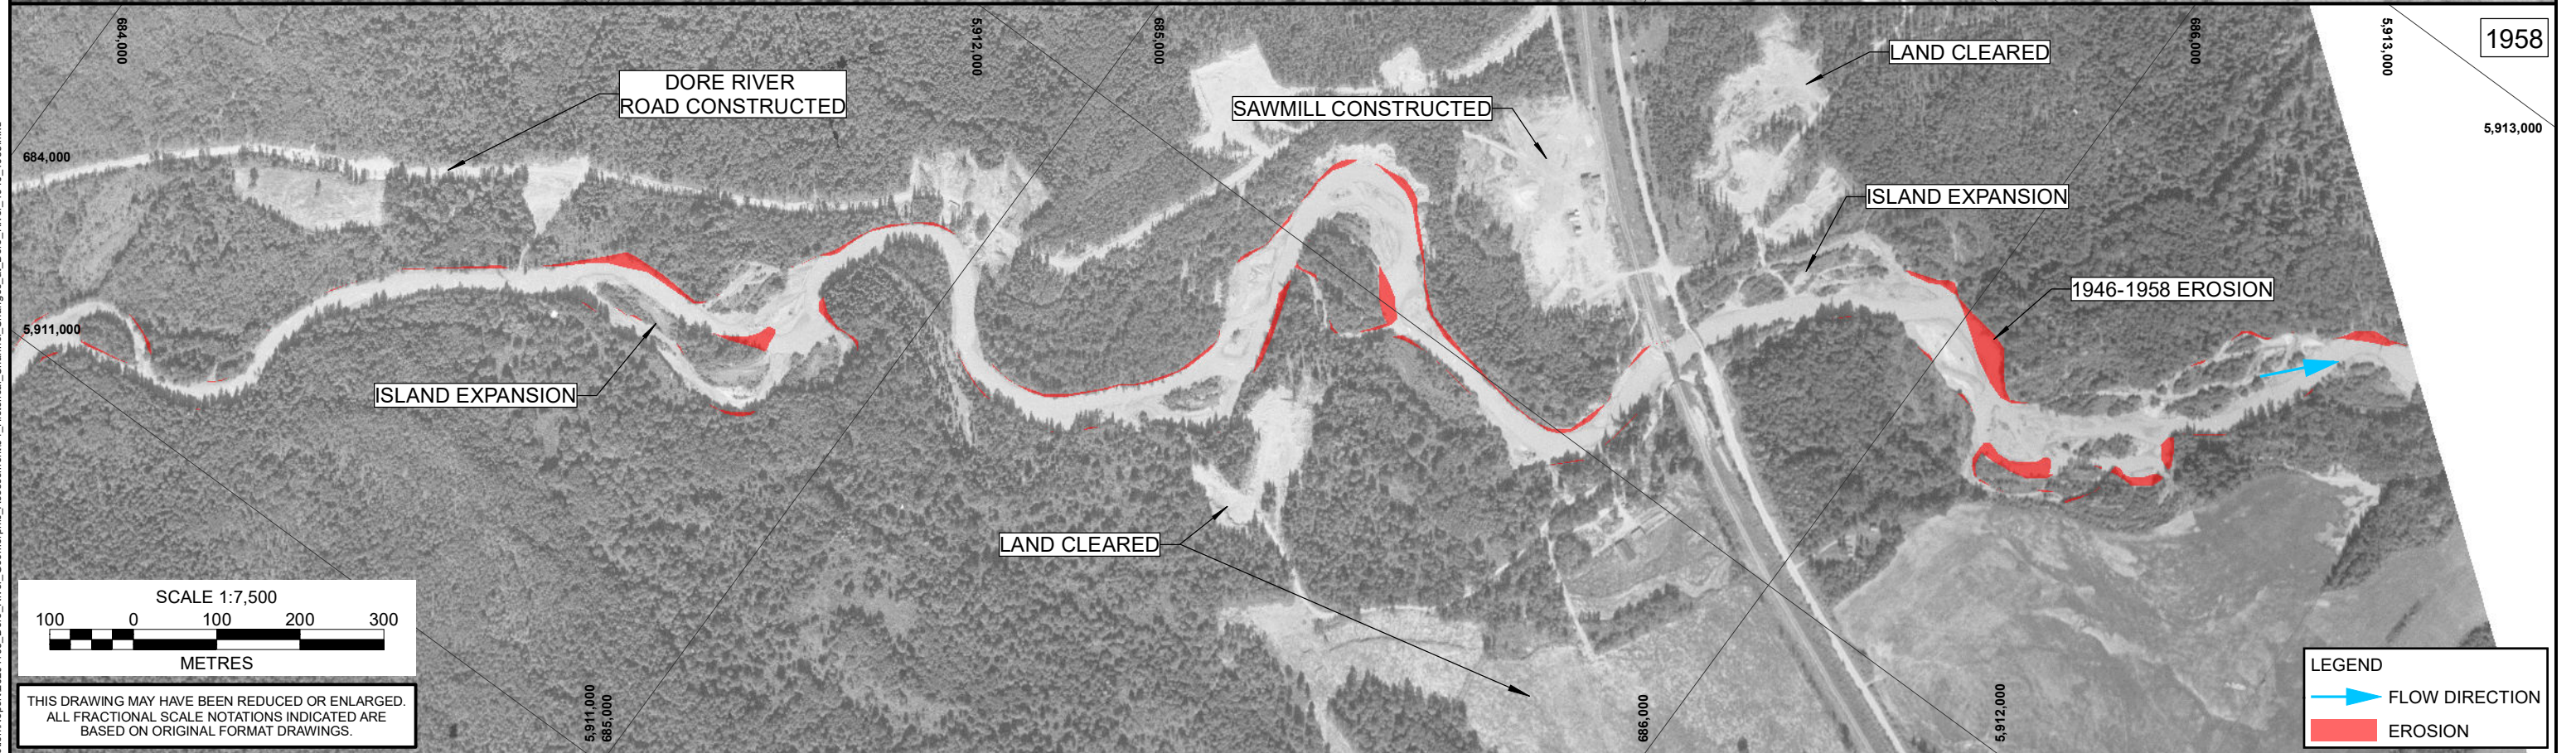
THIS DRAWING MAY HAVE BEEN REDUCED OR ENLARGED.  
ALL FRACTIONAL SCALE NOTATIONS INDICATED ARE  
BASED ON ORIGINAL FORMAT DRAWINGS.

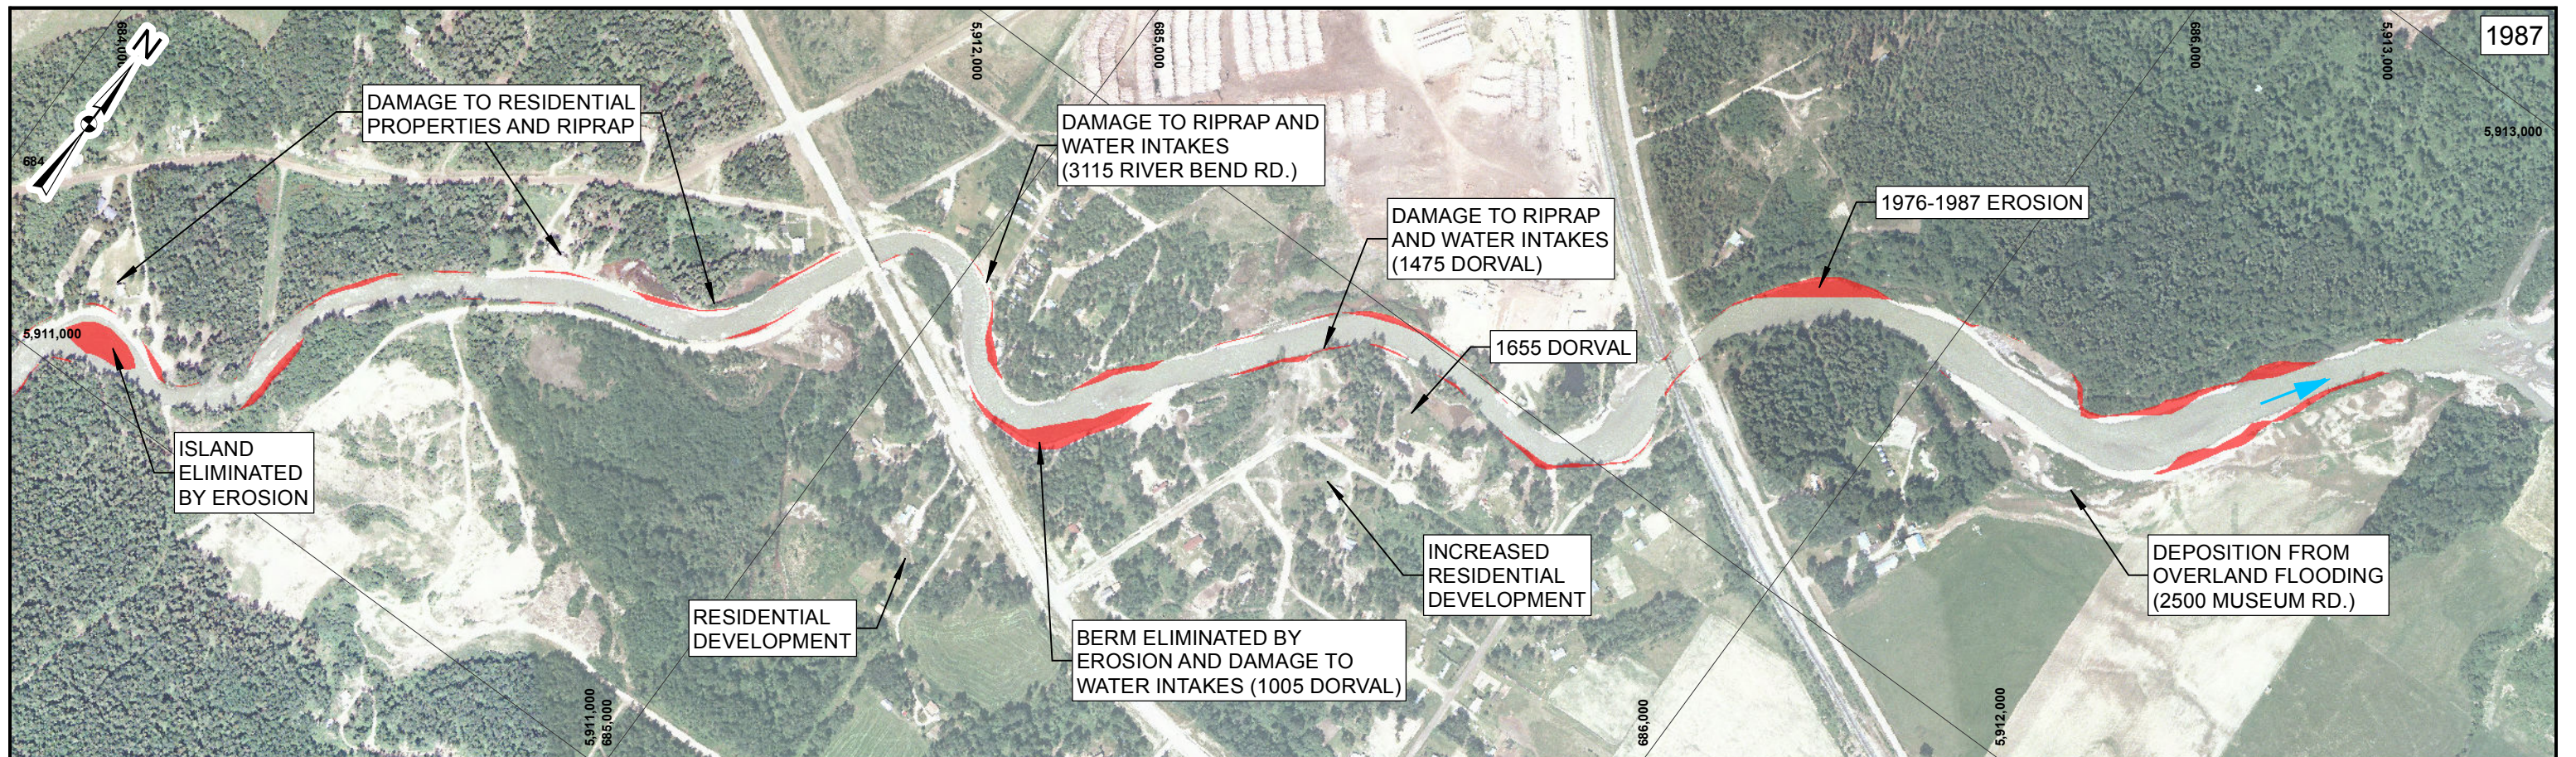
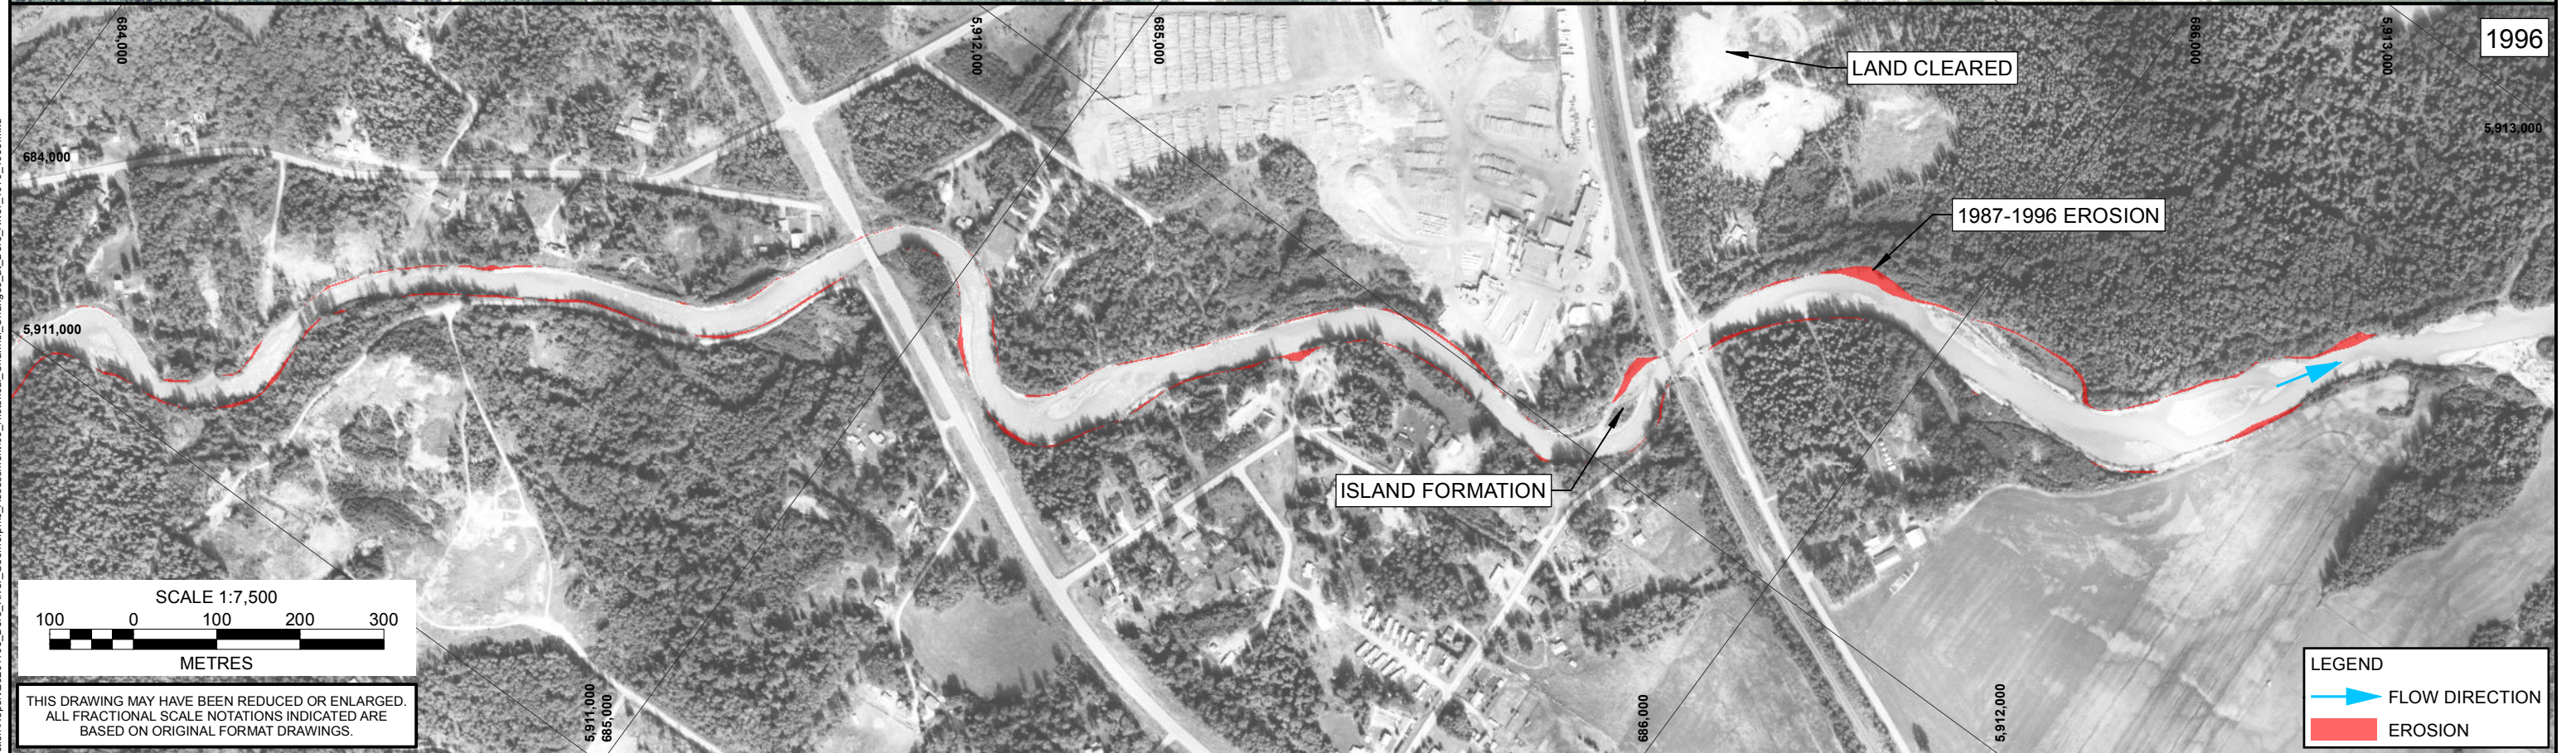
X:\Projects\1572006\GIS\Production\Report\202103\_Dore\_River\_Geomorphic\_Assessment\05\_Historical\_Channel\_Changes\_at\_Dore\_River\_1958\_1976.mxd
