## **Hydrologic and Geomorphic Assessment of the Dore River**

March 11, 2021 | Revision 2

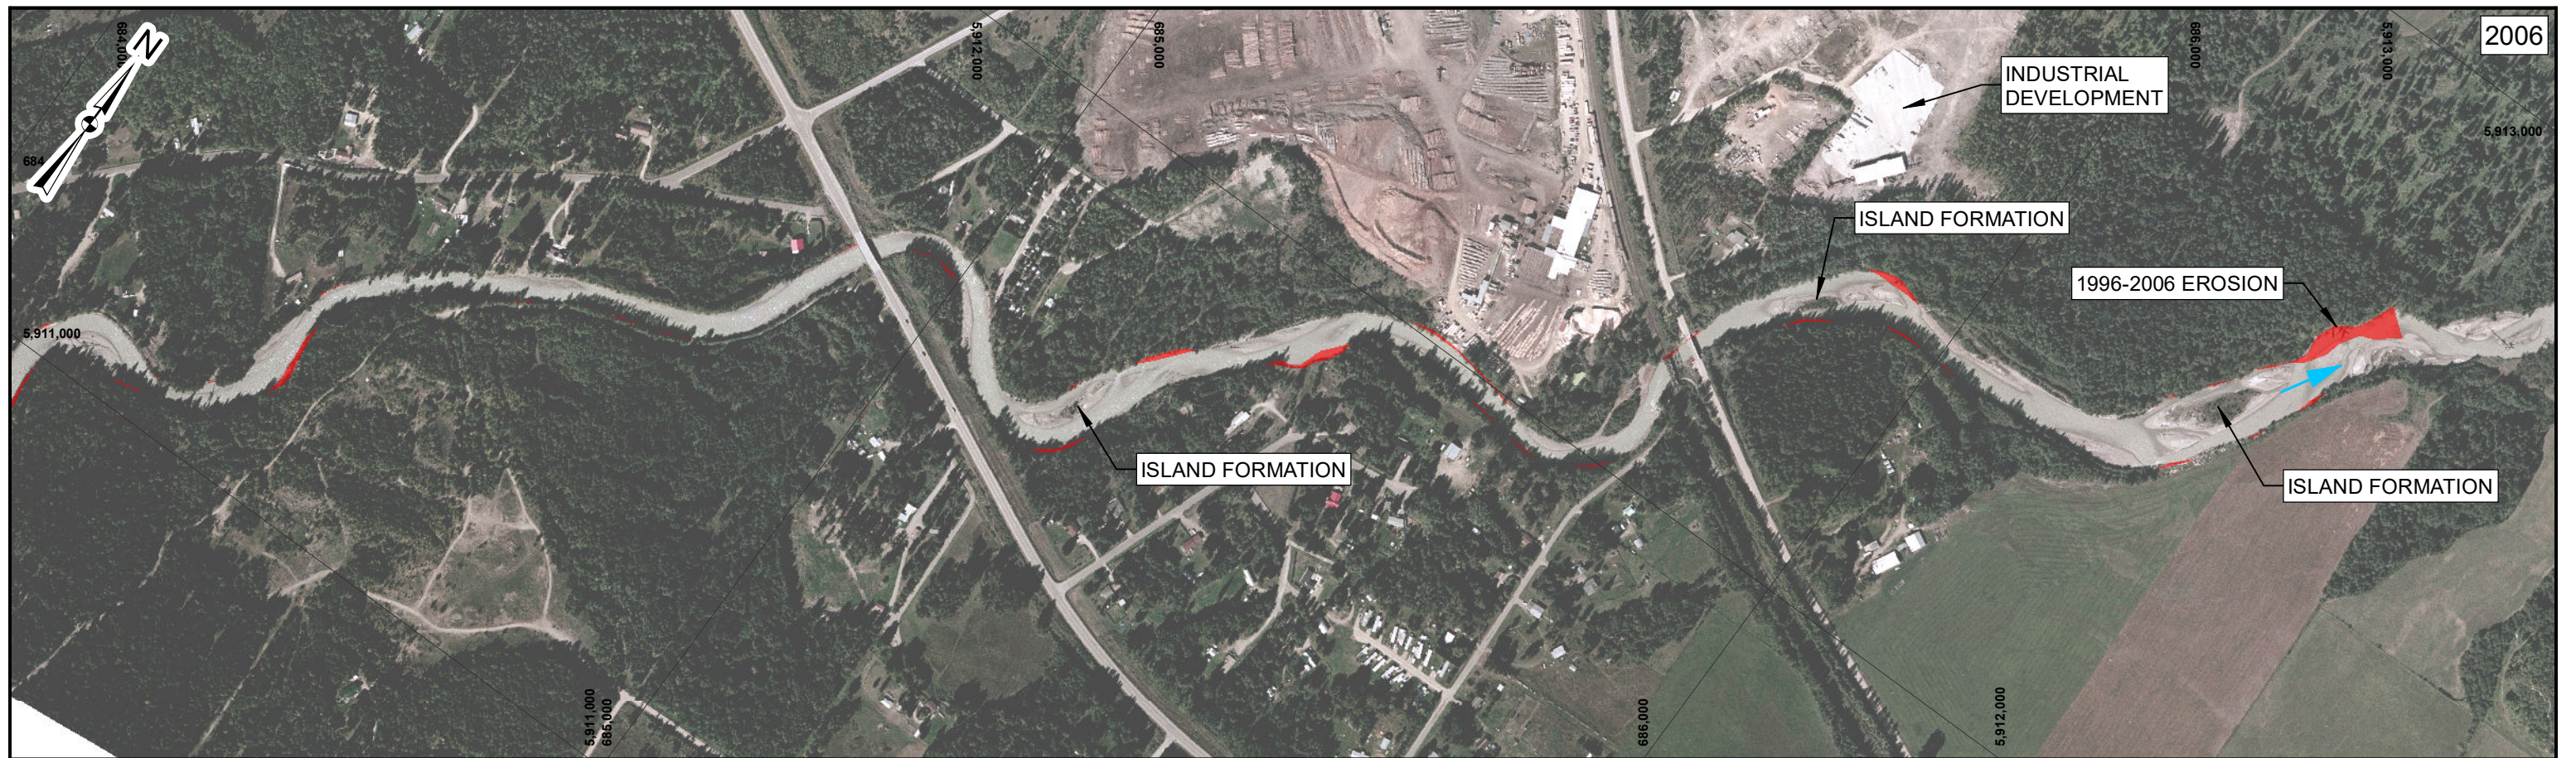
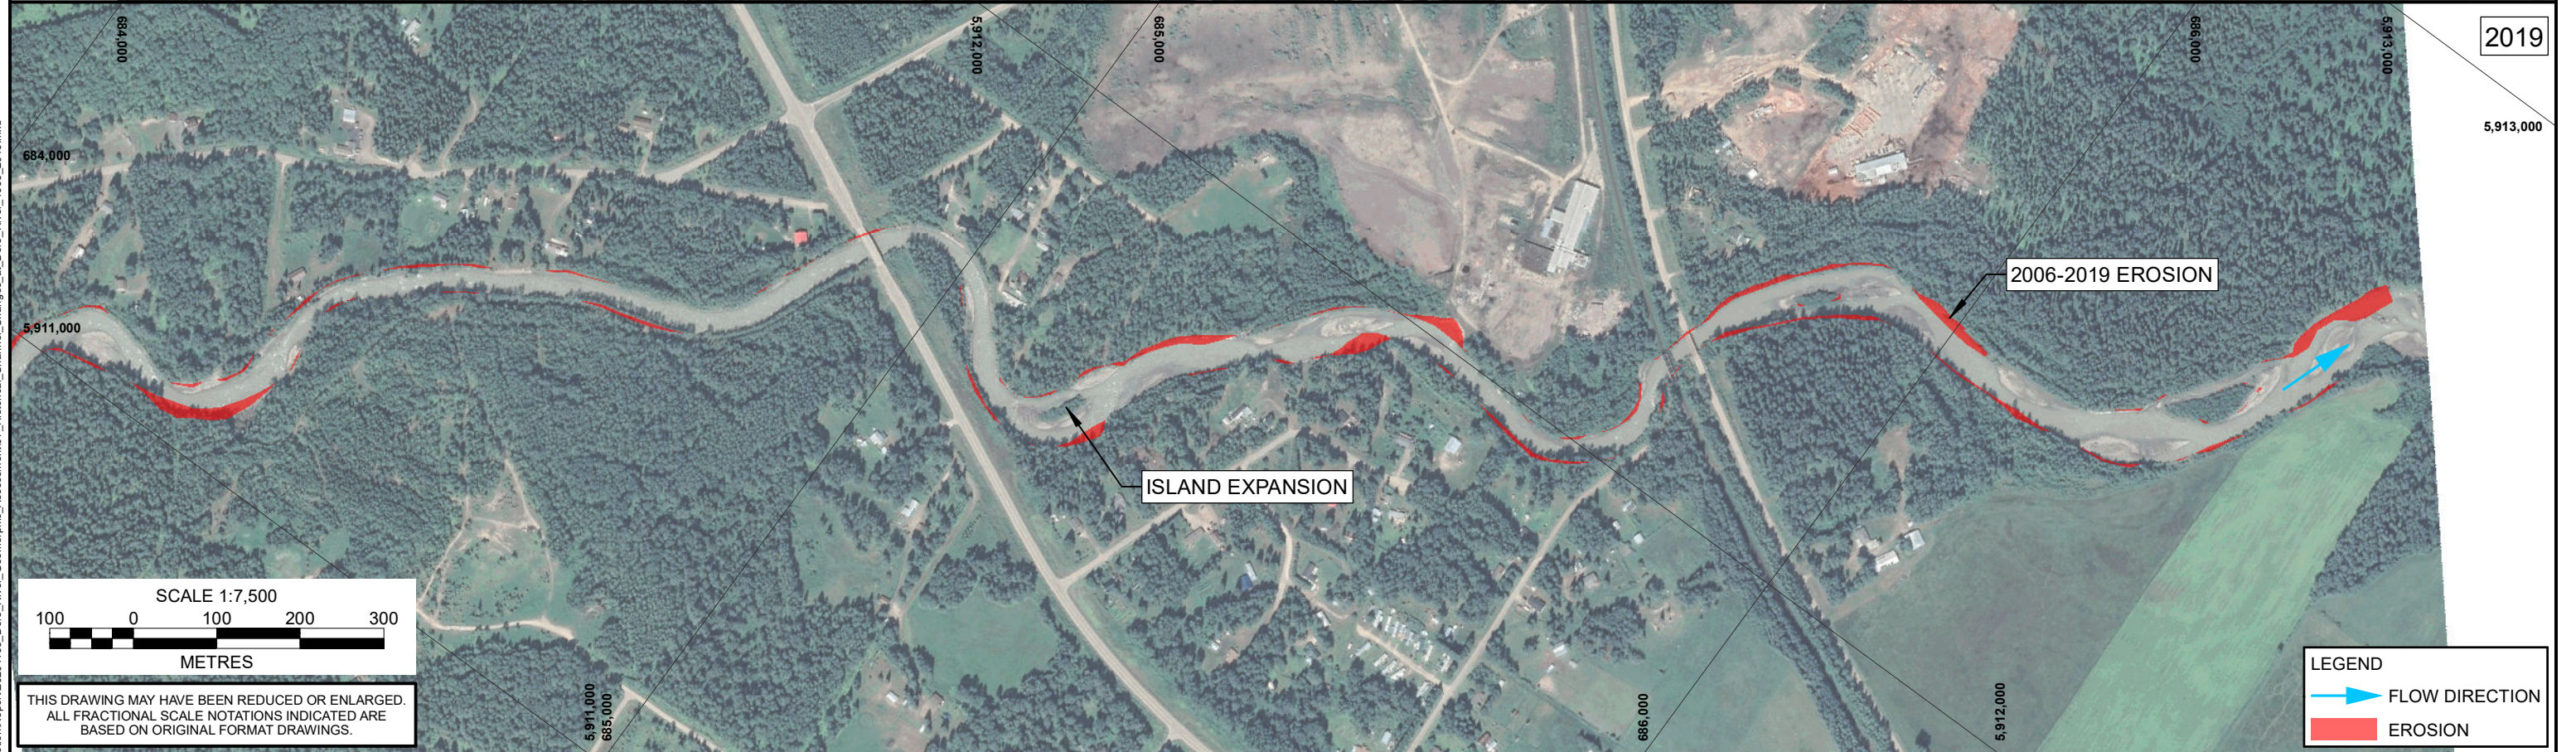
X:\Projects\1572006\GIS\Production\Report\202103\_Dore\_River\_Geomorphic\_Assessment\06\_Historical\_Channel\_Changes\_at\_Dore\_River\_1976\_1996.mxd
