**Invitation to Tender ES-21-01  
Construction Services for  
Cummings Road Regional Transfer Station Redevelopment**

**GEOTECHNICAL REPORT**

**PROPOSED RECONSTRUCTION OF  
CUMMINGS ROAD REGIONAL  
TRANSFER STATION, DL 9095,  
ALPINE DRIVE, REGIONAL DISTRICT OF  
FRASER-FORT GEORGE, B.C.**

**PROJECT No. K-5366**

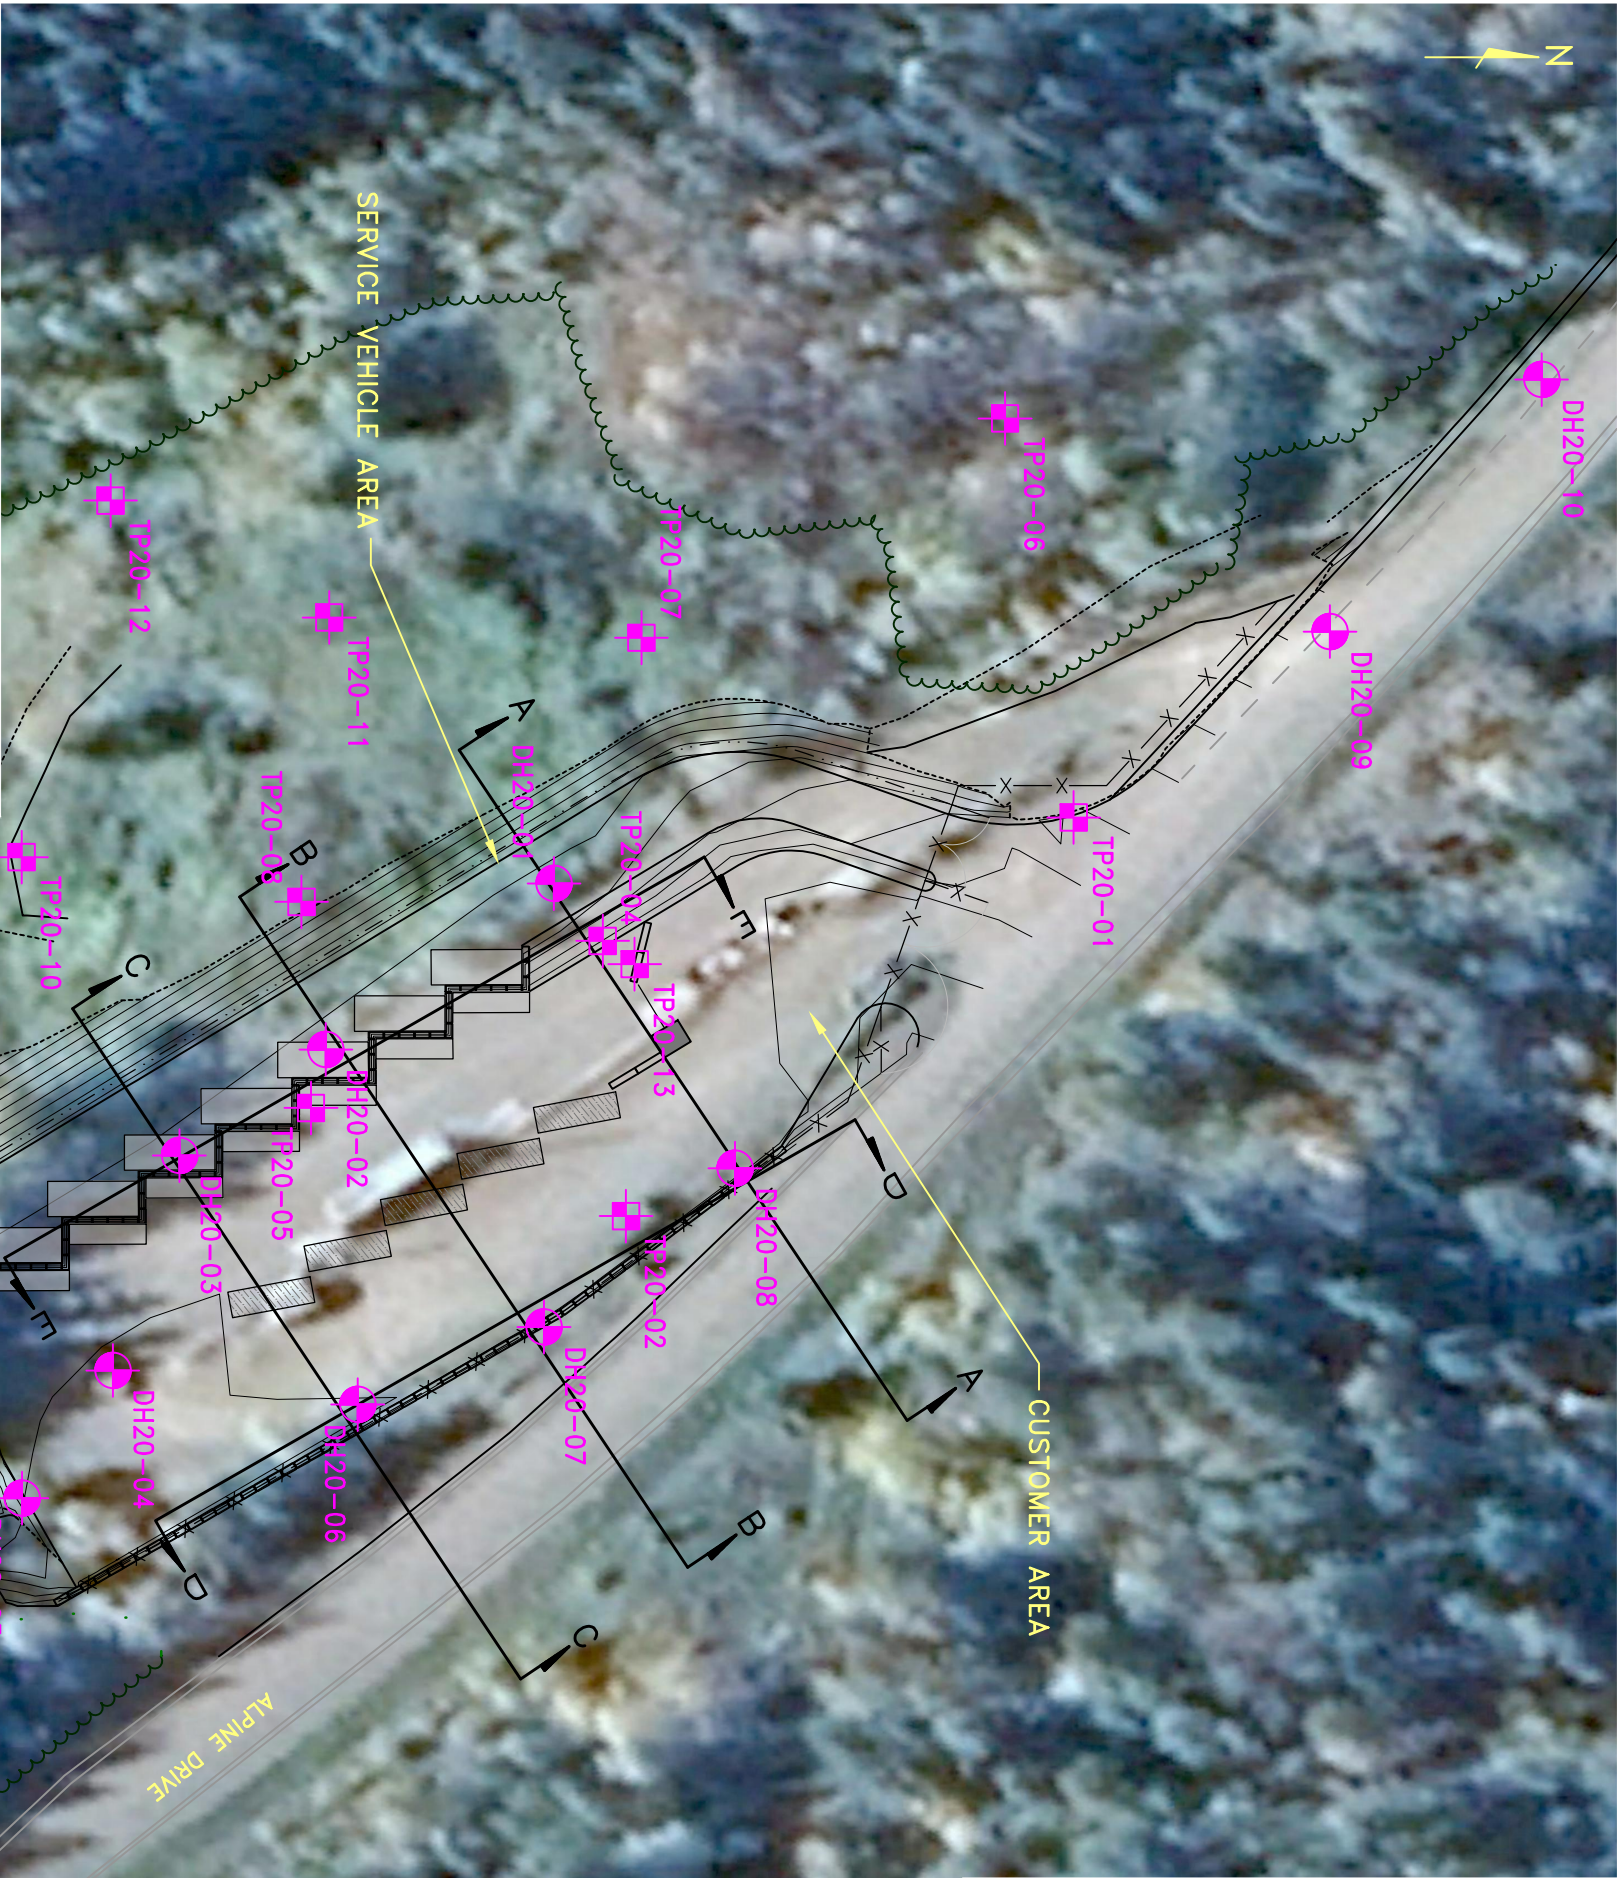
**Drawing 5366-A1**

The conceptual reconstruction plan for the proposed transfer station is shown on Drawing 5366-A1.

1. PROPOSED TRANSFER STATION LAYOUT TAKEN FROM MORRISON HERSHFIELD LIMITED DRAWING FIG. 2-CONCEPTUAL DESIGN DATED SEPTEMBER 18, 2020.
2. AERIAL PHOTO SHOWN IN BACKGROUND IS FROM Google earth, ©2020 Google, Image©2020 CNES/Airbus.
3. DRILL HOLE AND TEST PIT LOCATIONS ARE APPROXIMATE.

On May 26 and 27, 2020, GeoNorth personnel observed soil and groundwater conditions in thirteen test pits, designated TP20-1 to 13, excavated to between 0.8 and 4.0 m depth using a CAT 512D excavator. The results of our test pit investigation were presented to Morrison Hershfield in an email dated June 2, 2020 and after several discussions, we returned to the site on July 14 and 15, 2020 and observed soil conditions in an additional ten drill holes, designated DH20-1 to 10. Drilling was carried out using a track-mounted rig and solid-stem auger methods, contracted from KRG Drilling and Blasting Ltd. of Prince George. DH20-1 to 8 were within the existing station and were advanced to between 5.2 and 10.7 m depth. DH20-9 and 10 were along the new right turn lane adjacent to Alpine Drive and were advanced to 3.0 m depth. The locations of the test pits and drill holes were recorded using a hand-held GPS unit with an accuracy of 3.0 m and are shown on Drawing 5366-A1. The elevations of the test pits and drill holes were estimated from the topographic survey drawings by Koehler Land Survey Inc.

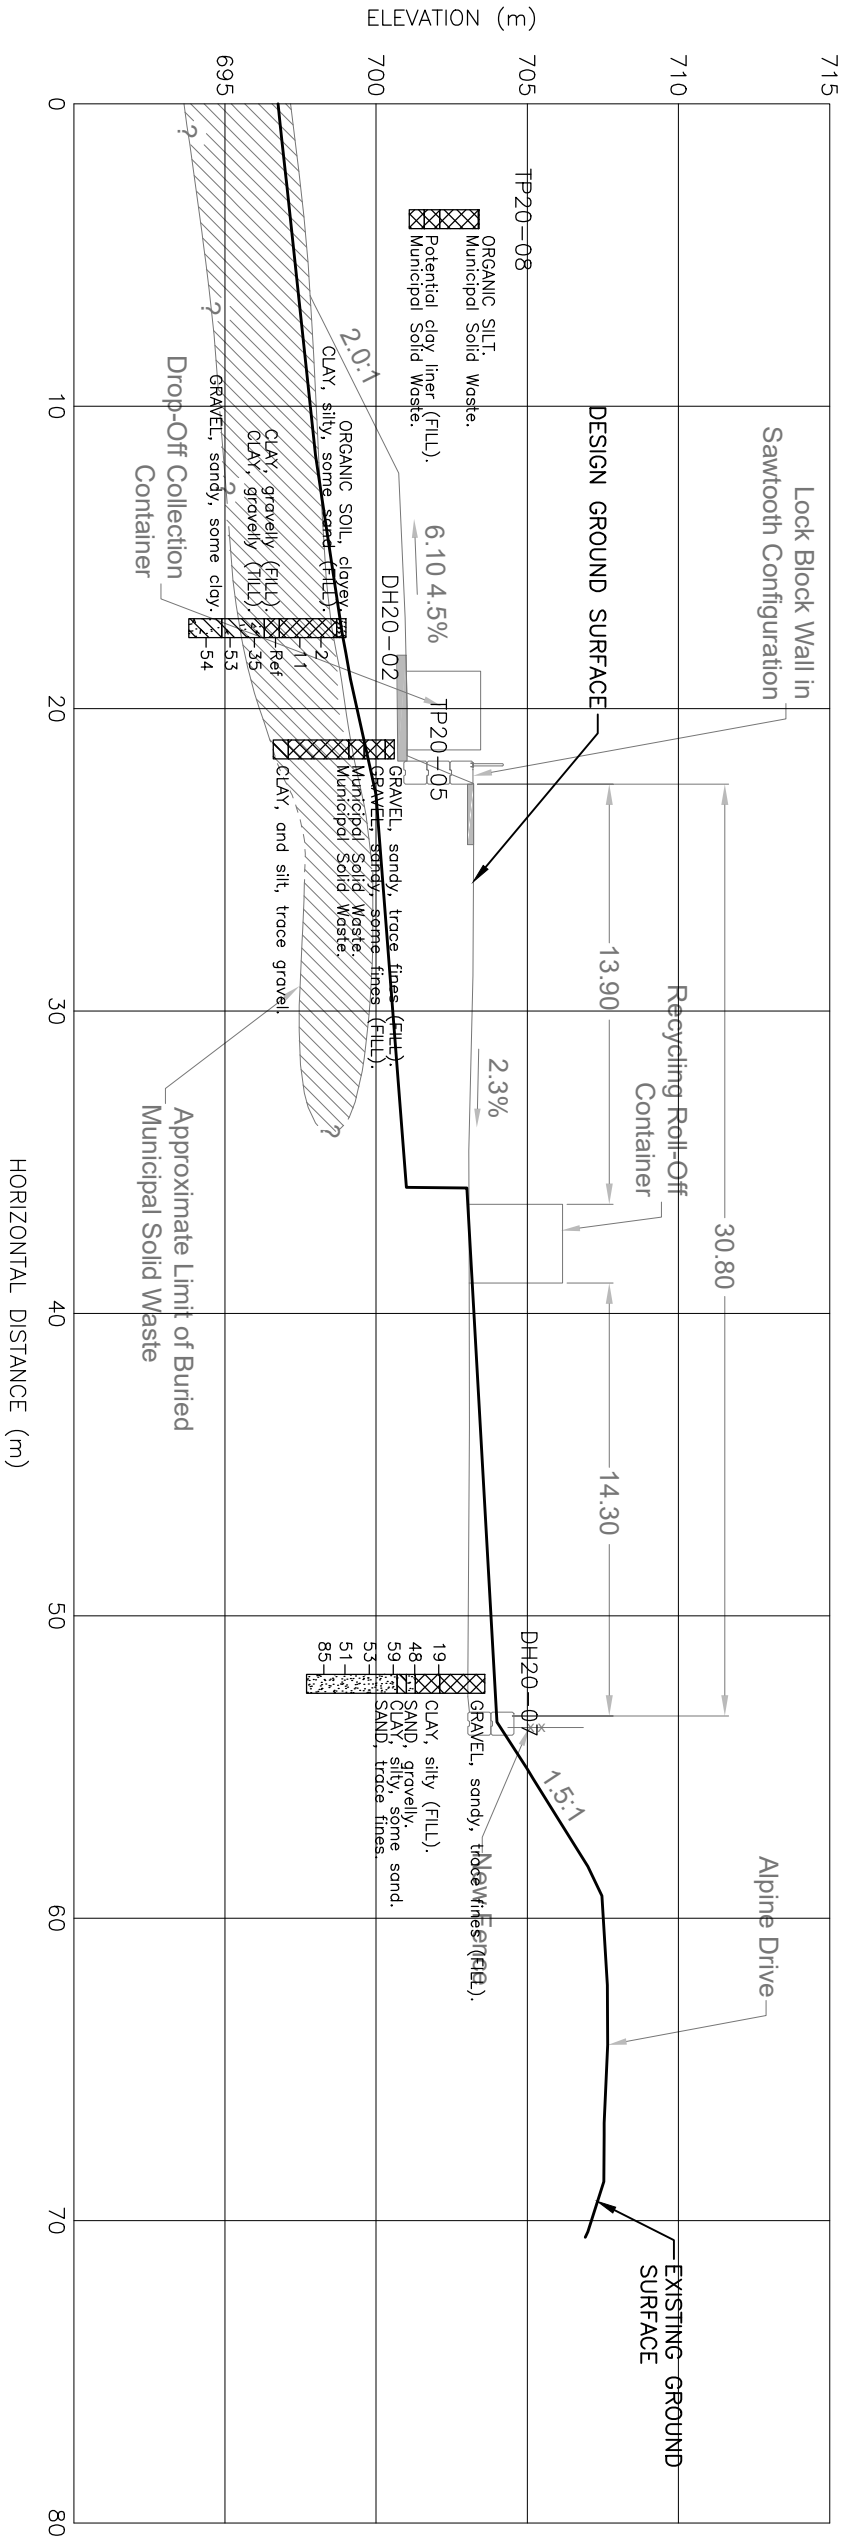
Cross Section B-B

- NOTES:
- PROPOSED TRANSFER STATION LAYOUT TAKEN FROM MORRISON HERSHFIELD LIMITED LIMITED DRAWING FIG. 4, DATED SEPTEMBER 18, 2020.

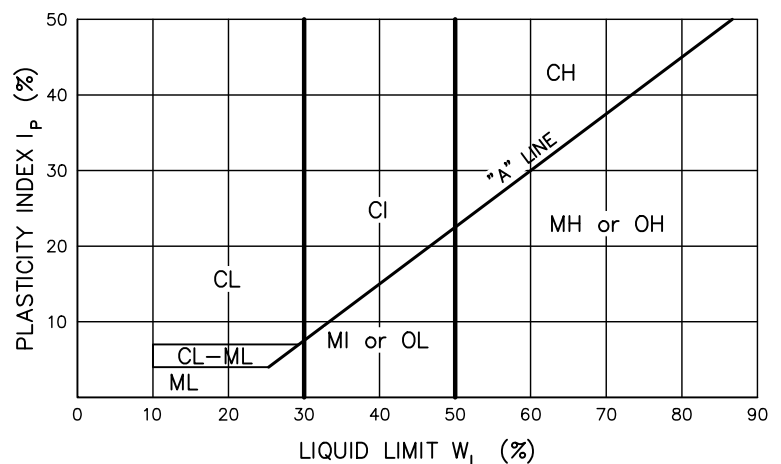
## PLASTICITY CHART

The results of Atterberg limits tests, used to define soil plasticity, indicate the silty clay, Unit 3 has a plastic limit between 19 and 22% and an average liquid limit of 43%. The Atterberg plastic limit defines the moisture content at which soil behaviour changes from semi-solid to plastic, and the liquid limit defines the moisture content at which soil behaviour changes from plastic to that of a viscous liquid. Laboratory tests show that the natural moisture content of the silty clay varies between 17% and 30%, indicating it will behave as a semi-solid to plastic material. The results of Atterberg limit tests on samples of clay till, Unit 5 indicates a plastic limit between 18 and 21% and an average liquid limit of 40%. Laboratory tests show that the natural moisture content of the clay till varies between 7.4% and 17.7%, indicating it will behave as a semi-solid material.

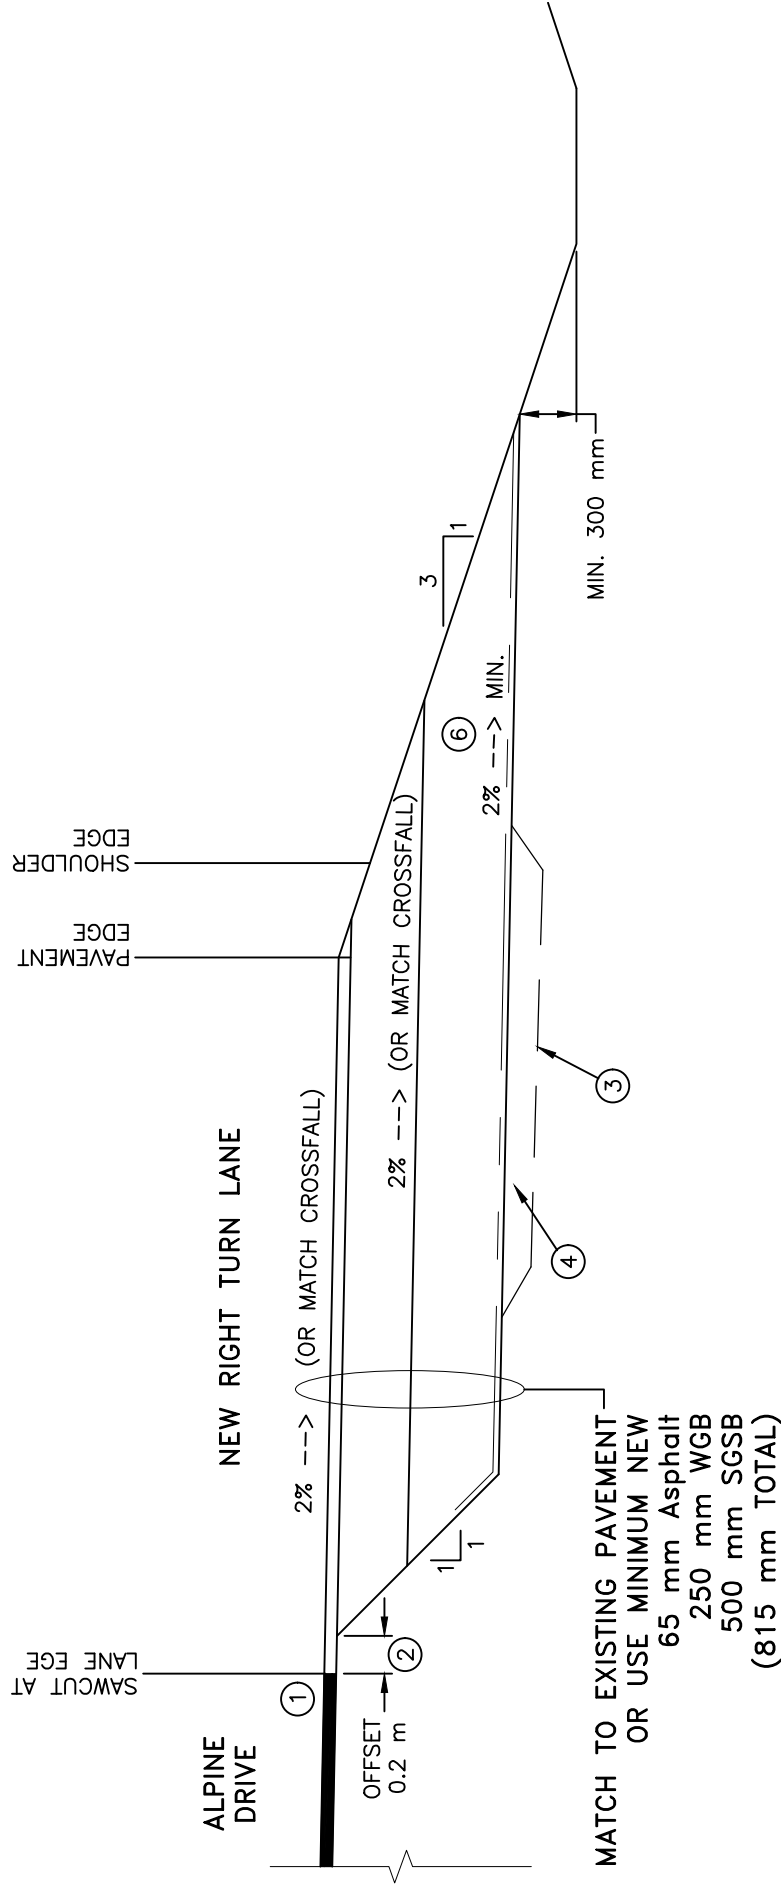
- ① MAKE CUT LINE AT 0.2 m AWAY FROM EDGE OF EXISTING PAVEMENT.
- ② FROM CUT LINE, OFFSET RIGHT 0.2 m AND EXCAVATE DOWN AT 1H:1V TO THE TOP OF THE NEW SUBGRADE AT 815 mm DEPTH.
- ③ AS REQUIRED, SUBEXCAVATE TO REMOVE SOFT SOIL FROM EXISTING DITCH OR WET AREA.
- ④ FILL DITCH BOTTOM WITH A GRADATION SIMILAR TO SUBGRADE SOIL OR USE SGSB.
- ⑤ SLOPE SUBGRADE AT 2% CROSSFALL TO OUTSIDE EVERYWHERE, AND ALL OTHER COMPONENTS AT 2% OR TO MATCH.

we recommend matching the new pavement structure thickness to that of Alpine Drive or use the minimum thickness noted in Table 2, below. For constructing the public and service vehicle access routes, we recommend using the following structures:
