## **Detailed Post-Wildfire Natural Hazard Risk Analysis Teare Creek Fire (G30210)**

**BC Wildfire Service**

**Westrek Geotechnical Services Ltd.**

March 12, 2024  
File No. 023-215

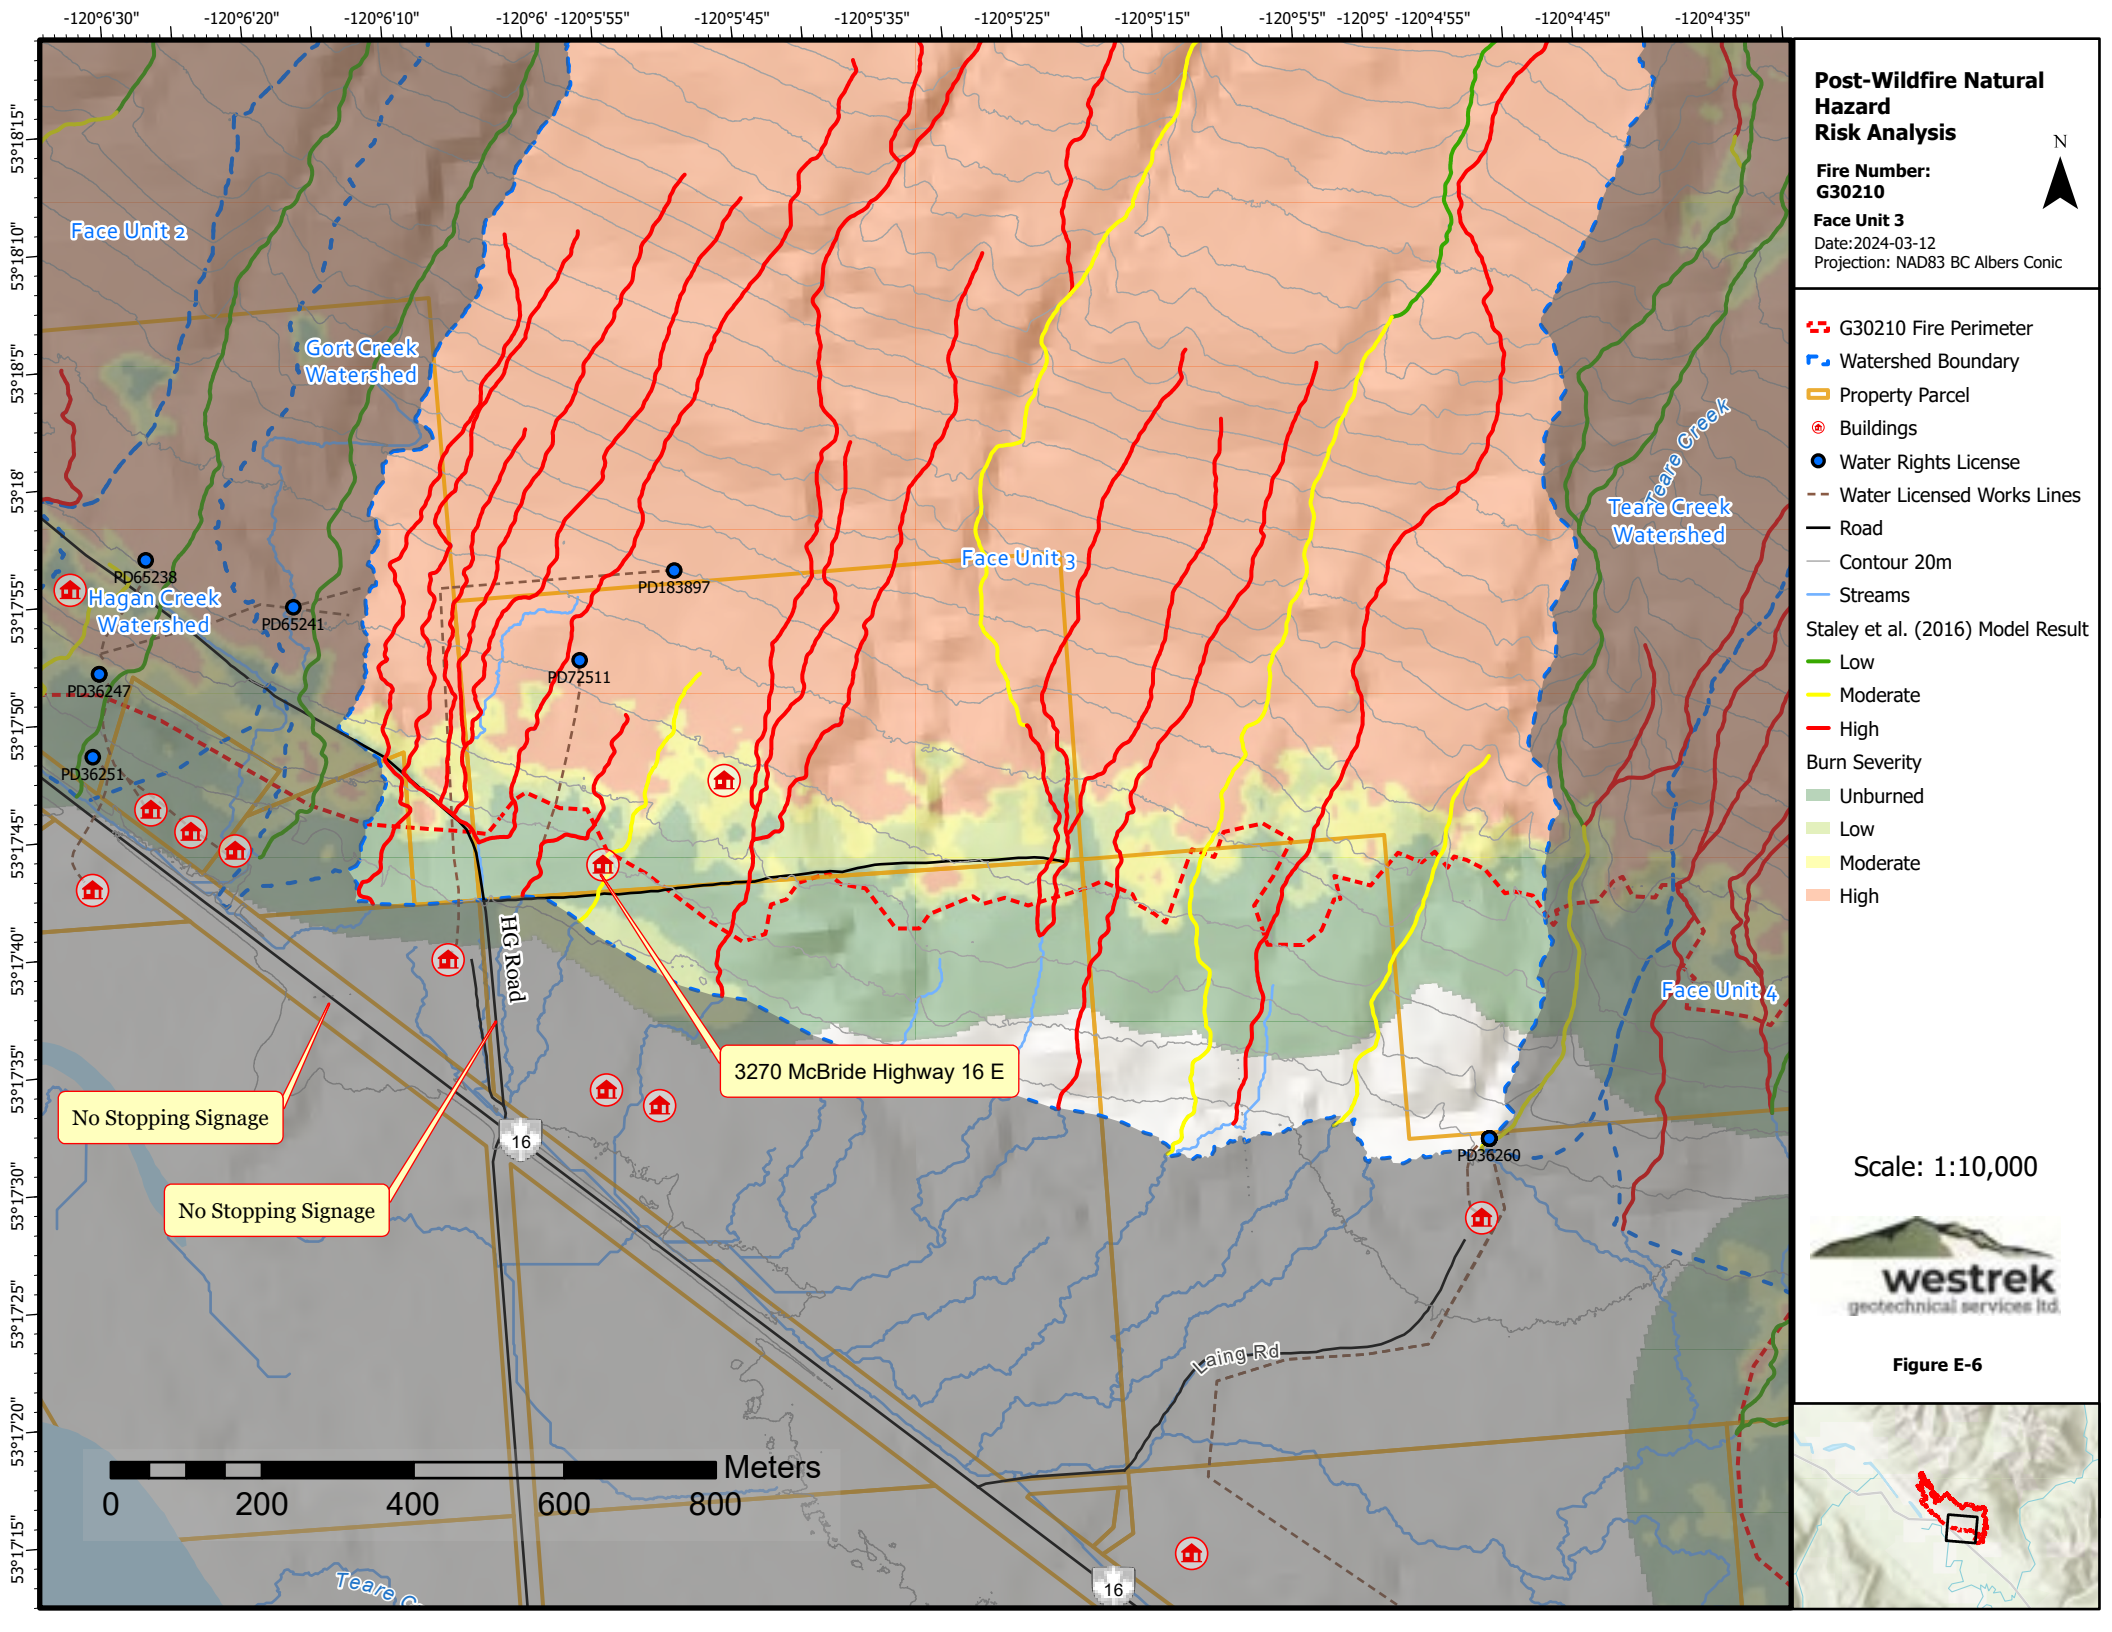
**Photo 21:** View looking north at Face Unit 3. The residence at 3270 McBride Highway 16 E is located at centre. Immediately upslope of the residence the slopes are mapped as having a low or moderate burn severity.

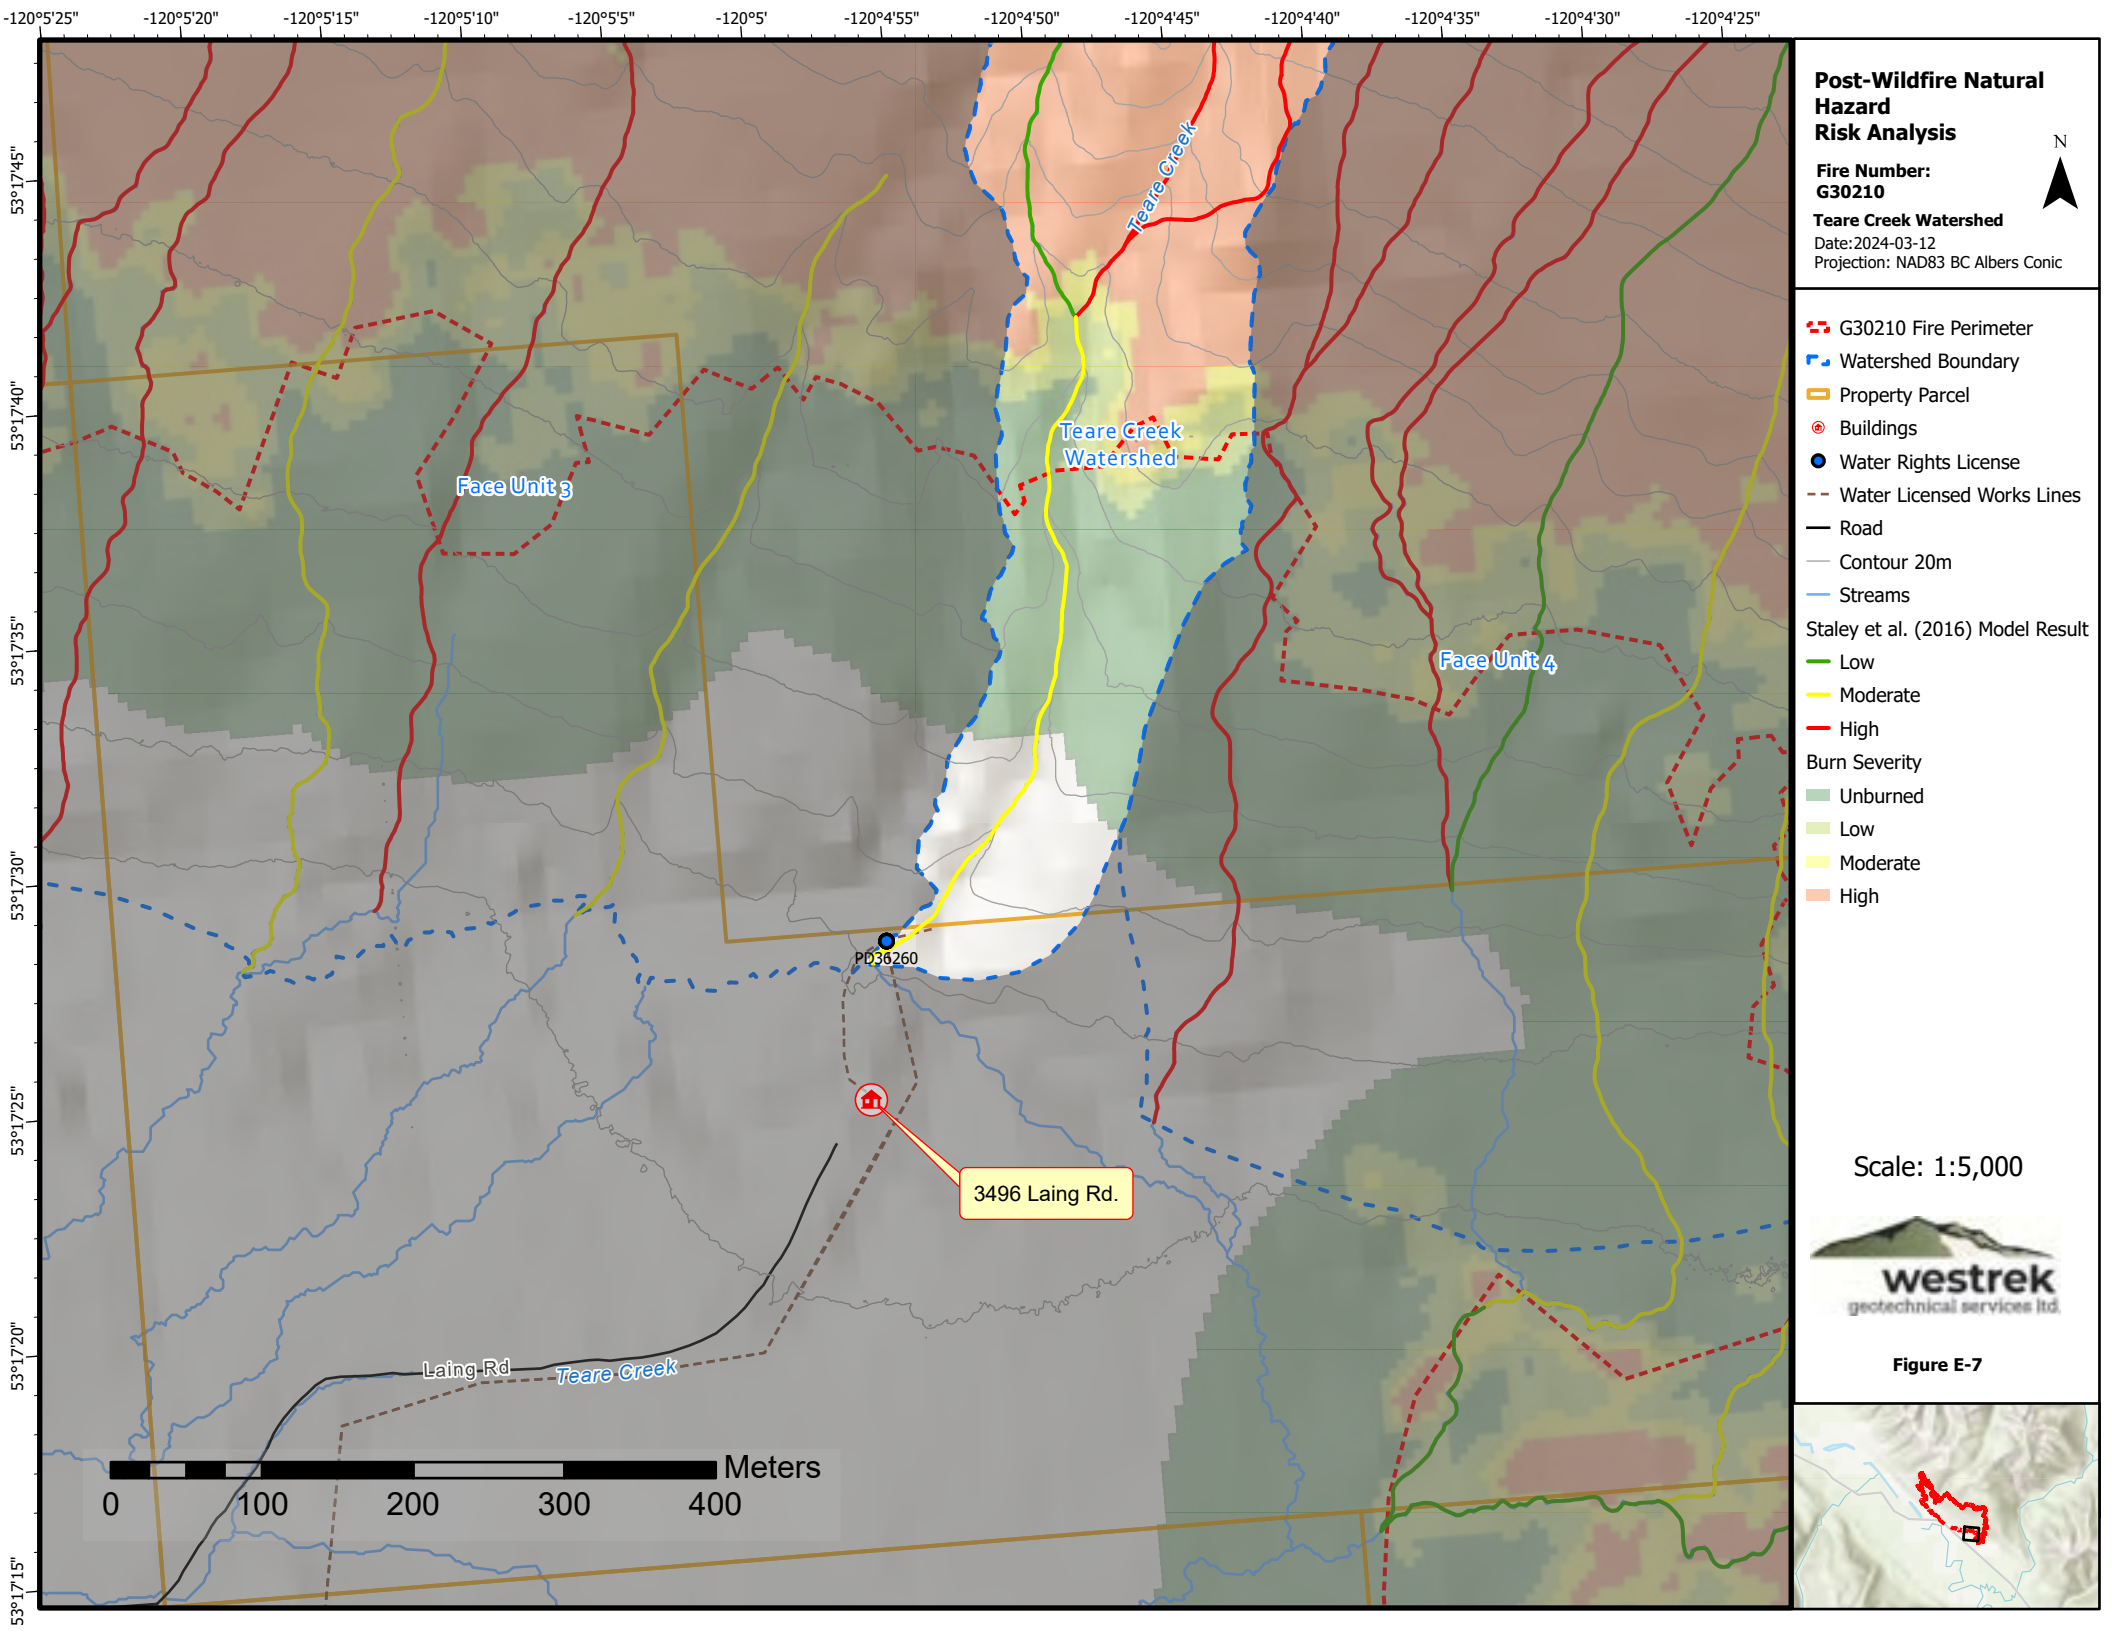
**Photo 25:** View of Teare Creek on the fan at the base of the slope; flow has been diverted to the east in an excavated channel. During a flood, the creek could overtop its banks and flow downslope towards the residence.
